AeroMaster

48-142

He-111 Collection Pt. II

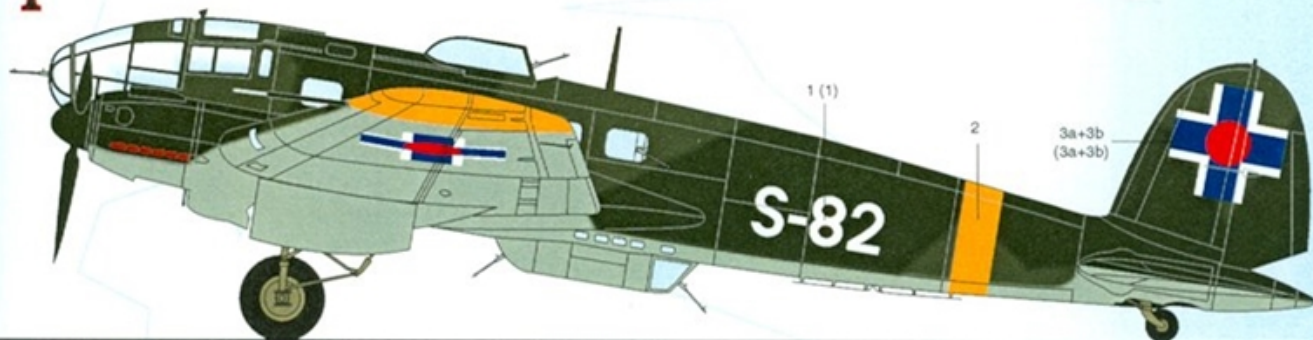
AIRCRAFT 1 • He-111H-3 of the Slovakian Air Force, Trencin, spring of 1943. Uppersurfaces are RLM 70 Schwartzgrün and RLM 71 Dunkelgrün; undersurfaces RLM 65 Hellblau. Former Luftwaffe markings over painted. Spinners and propellers RLM 70. Note RLM 04 Gelb tips of wing undersurfaces.

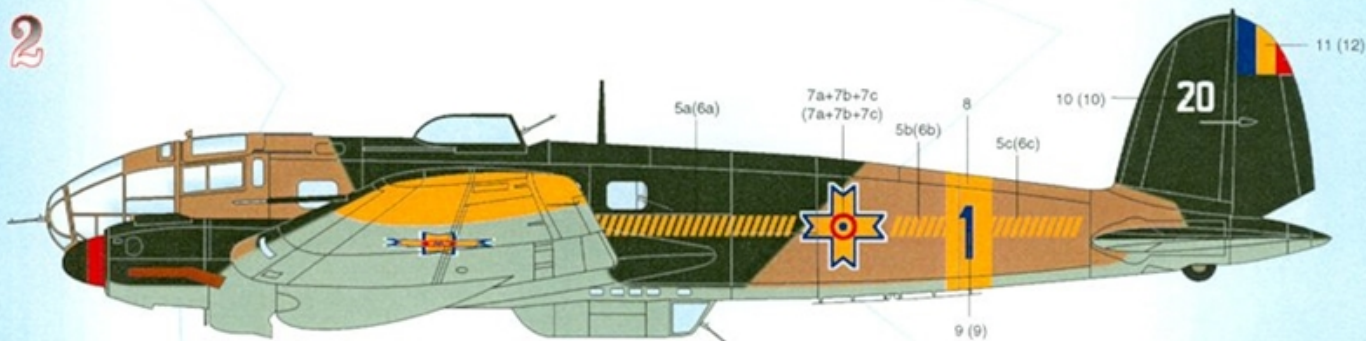
AIRCRAFT 2 • He-111H-3 of the Grupul 5 of Rumanian Corpul 1 Aerian, operating in the Zaporozh'ye area of the Ukraine, early 1943. Uppersurfaces are RLM 70 Schwartzgrün and RLM 79 Sandgelb; undersurfaces RLM 65 Hellblau. Spinners are according to references RLM 70 with RLM 23 Röt stripe. Propellers RLM 70. Note large RLM 04 Gelb panels on outer wing undersurfaces.

Possibility exists that this A/C had splinter sections of RLM 79 over the standard He-111 camouflage pattern of RLM 70/71. Use your discretion.

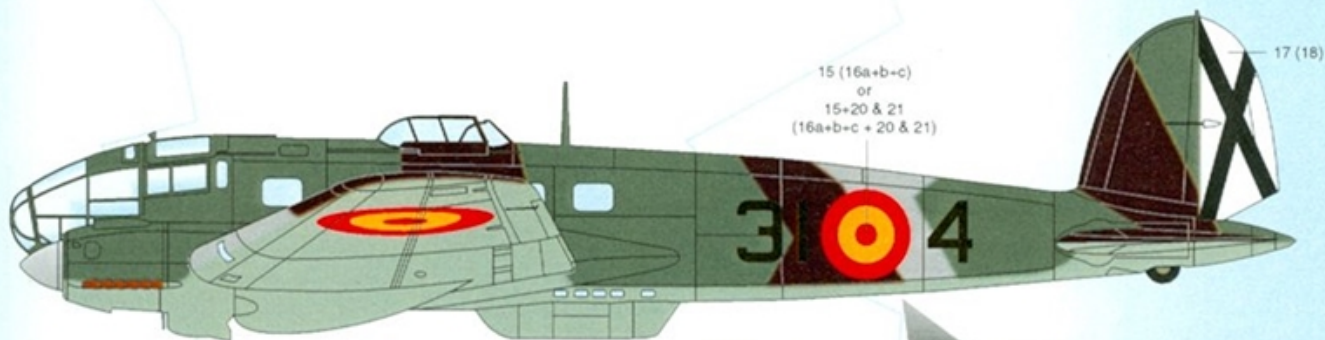
AIRCRAFT 3 • CASA-built He-111H-16, of Ala 31, Spanish Ejercito del Aire, late 1950s. Uppersurfaces painted in a splinter pattern of Dark Green (RLM 62), Medium Gray (RLM 63) and Brown (RLM 61), undersurfaces Light Blue (RLM 65?). Spinners in natural aluminum. Paint rudder White before applying decals #17 and #18.

Note: This A/C may have had a thin White outline to the fuselage codes. These outline are provided to you separately, and are to be applied last. Also, order of the right side codes are unknown, our choice would be 4-31. Decals are separate to give you any option you may want.

Note: One of our references show the codes "31•4" to have a white border, while another does not. We have provided the border separately for those wishing to use it. Consult your references.
