J 28B Vampire Painting and marking information

J 28B Vampire Painting and Markings

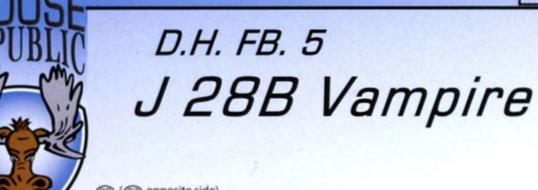
J 28B, 28345 Yellow Filip - F4 Frösön/Östersund 1954. No information regarding type of "No Step" areas, but it was probably marked in all six positions since that was the standard around this time. Hard demarcation lines between green and grey.

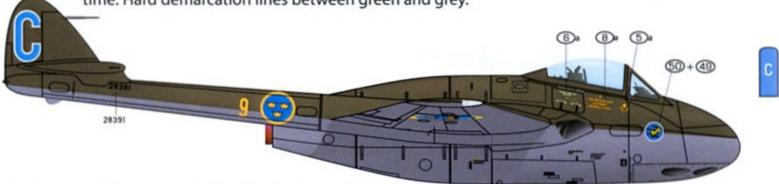
J 28B, 28147 Blue Cesar, F9 Säve/Gothenburg. The second squadron's badge "Bonzo" on right side of the nose. The aircraft may have had markings similar way to 28122, i.e., it may have lacked the "No Step" areas over the outer flaps. Hard demarcation lines between green and grey.
