Many of the U.S. Navy carrier borne fighter-bomber squadrons of the period actually outscored their fighter squadron counterparts. The USS Randolph's two Hellcat squadrons followed this pattern, with VBF-12 claiming 74 kills to VF-12's 51. Lt. (jg) Daniel Carmichael joined VBF-12 in January 1945 having already scored 9 kills with VF-2 in 1944. By the end of May "Danny" Carmichael had earned a Silver Star and a DFC while flying air support for the two Jima and Okinawa landings as well as air strikes on Honshu and Tokyo. He also added 4 confirmed kills to bring his tally to 13, which are proudly displayed on the starboard side of #59, the Navy way.

For an aircraft with a production run well over 12,000 machines, the various production variants of the Hellcat have remarkably few external differences. Carmichael's aircraft was in every way a bog standard F6F-5. It carried six lower wing 5" HVAR stub mounts, and as a mid-production machine, did not have the small windows aft of the canopy that were common to the F6F-3 and early -5s. On the day depicted here, Carmichael appears to have been carrying an older drop tank that was still painted white - a carryover from the tri-color camoufl

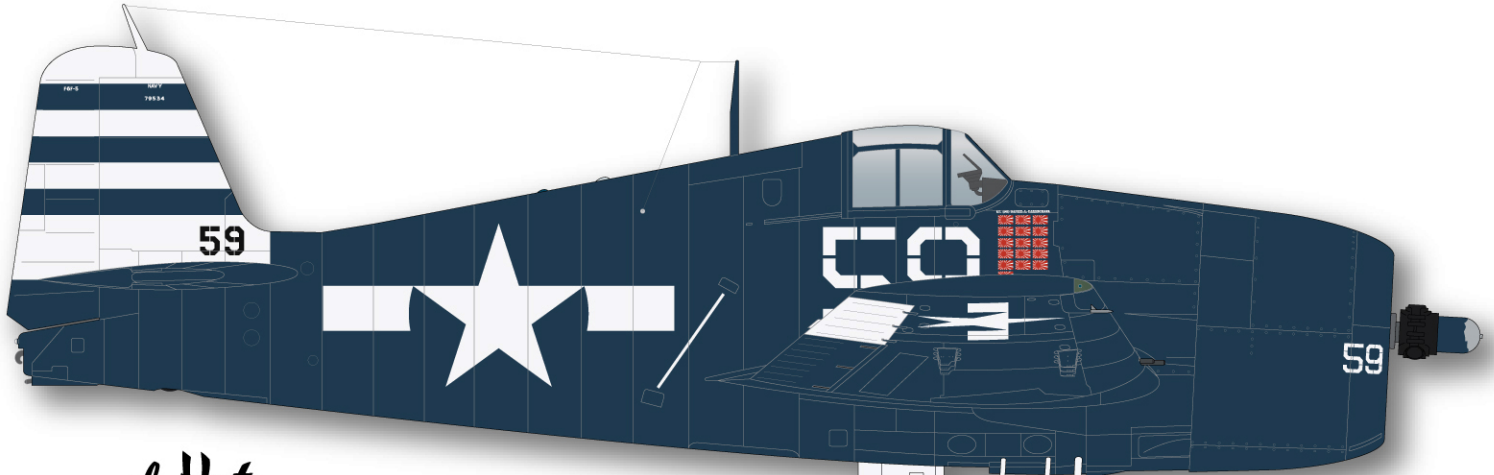
Detail Note

The Gloss Sea Blue paint on the front of the prop hub was mostly worn off. The aircraft otherwise appeared fairly unweathered.

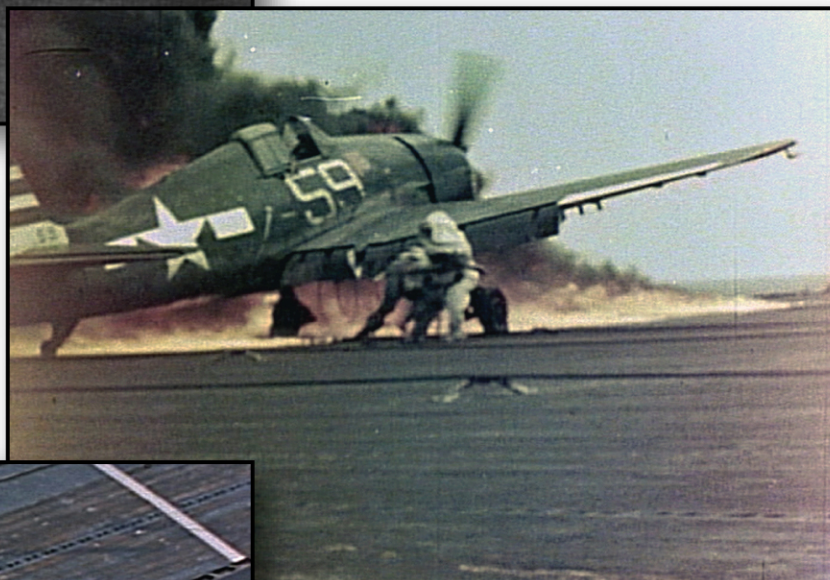
Right: A fireman's mate pulls #59's pilot to safety as the aircraft burns. Note the prop still turning, although it's a safe bet the magneto switches were off by this point.

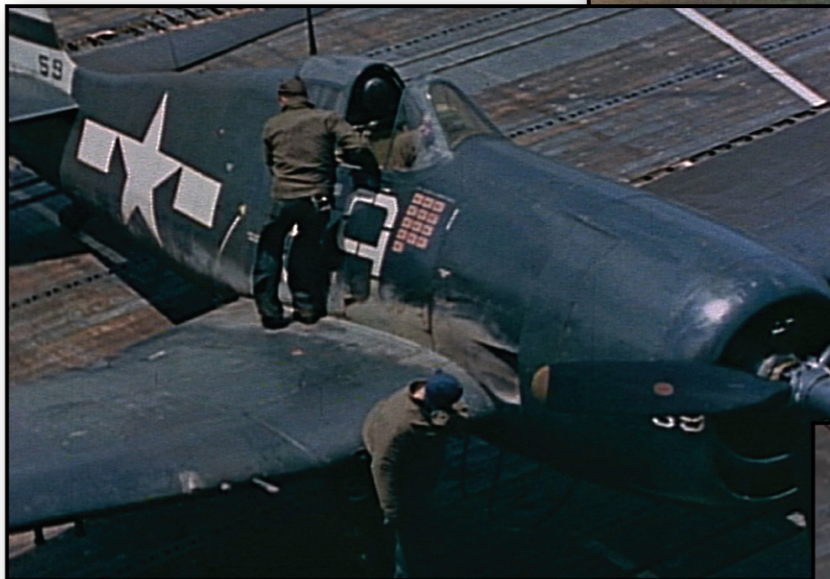
Above: View showing flight deck crew preparing to tow #59 off the deck. This view shows Carmichael's 13 kills and the location of the markings and the characteristic dusty grey Hellcat exhaust stain pattern. Note the tape over the gun barrels and the leading edge at the outer gun position as well as the overall well kept appearance of the airplane. The taped over guns and the fact she carried a drop tank back to the ship almost certainly means this was a mission where no Japanese aircraft were encountered. Virtually no paint chipping other than the prop hub dome is visible. Note the red wing fold locking pin indicator just outboard of the crewman's feet.

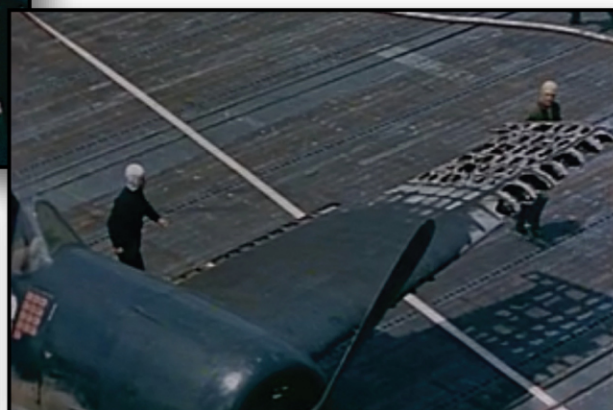
Right: The charred left wing of #59. Note the fabric burned away on the flaps (as it is on the elevator visible in other photos), and the aluminum skin burned completely away on the outer wing. It is doubtful that #59 ever flew again, and likely she was stripped and then dumped overboard.
