Aviaology The Coastal Strike Wings

Mosquito F.IIs & FB.VIs

The Outriders: 333 (Nor.) Squadron 1943-45

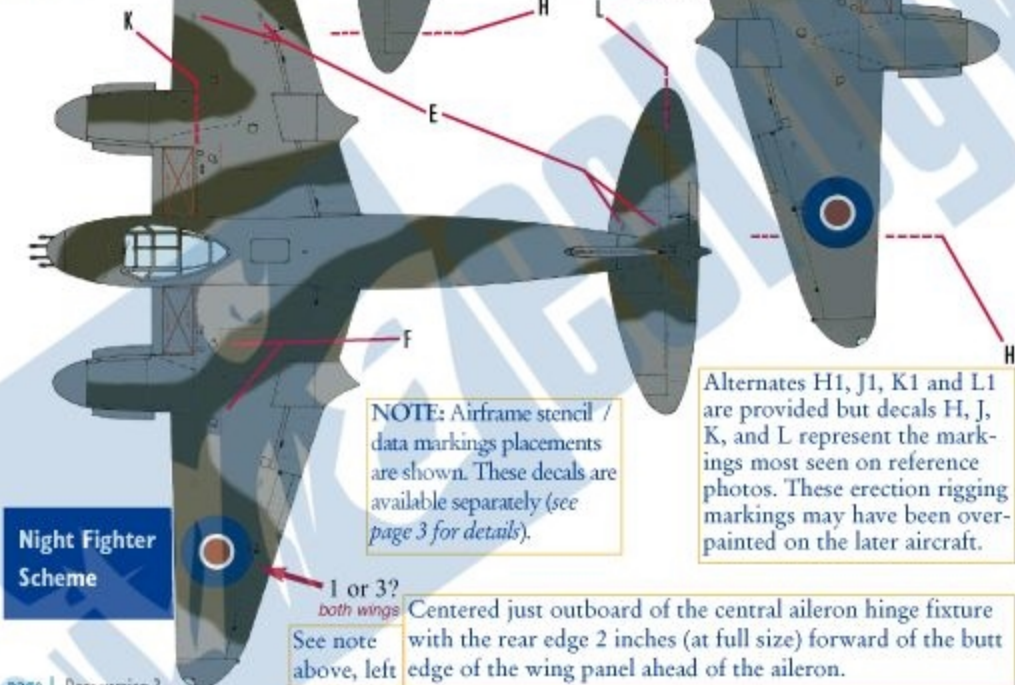
NOTE: Airframe stencil / data markings placements are shown. These decals are available separately (see page 3 for details).

Alternates H1, J1, K1 and L1 are provided but decals H, J, K, and L represent the markings most seen on reference photos. These erection rigging markings may have been over-painted on the later aircraft.

I or 3?
both wings
See note above, left
Centered just outboard of the central aileron hinge fixture with the rear edge 2 inches (at full size) forward of the butt edge of the wing panel ahead of the aileron.

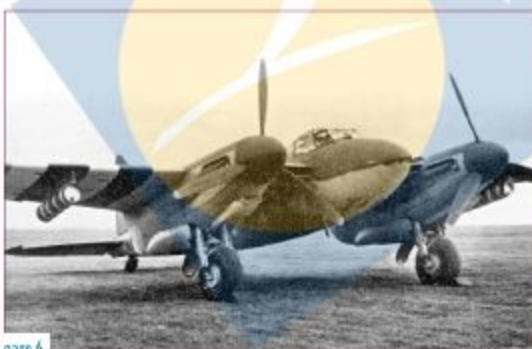
A&AEE photo 11908

Mosquito FB.VI HR135 of 248 Sqn pictured in August 1944 while on loan to the Aircraft & Armament Experimental Establishment (Boscombe Down) for the purpose of testing both D/C Mk.XI and Mine A Mk.VIII (soon here) ordnance carriage on the wing hardpoints. The lower outline of the UBC fairings appear to have been altered from their usual shape (bright areas indicating new sheet metal?) to make the mines "snug up" properly to the carrier crutch pads. A Sea Mosquito used to test this same ordnance in October 1945 exhibited similarly altered UBCs. Note the SDS-A finish and A.E.A.E. invasion stripes still present on the wings and rear fuselage.

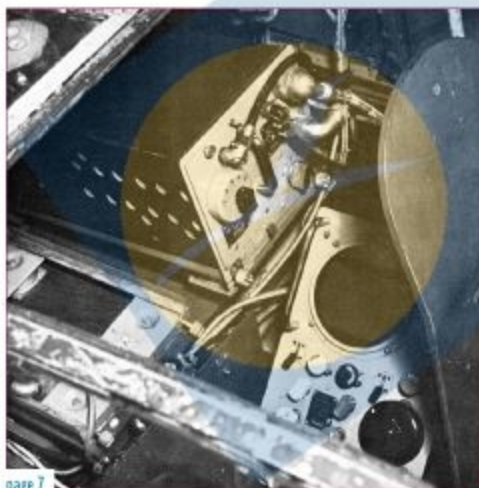
The two main components of Gee Mk.II, ARI 5083, as embodied in a wartime Mosquito FB.VI. The unit behind the pilot's seat is a Type 62A indicating unit and that mounted on the rear decking is the R1355 receiver. Not visible in this view are the switch panel, which is normally mounted on the port canopy sill framing just above the R1355, and the aircraft's Junction Box 1, which is mounted horizontally, to the left of the navigator's seat, on the box structure which supports the seat. Other components of the system are elsewhere in the aircraft.

In addition to the main units illustrated here, Gee Mk.II required any one of at least three different vertical wire aerial (antenna) installations.⁶ The initial form of ARI 5083, as described and illustrated in Mosquito technical documentation, shows a long cable run (green wire on the R1355 RF Unit) to an aerial strung vertically on a rear fuselage bulkhead. Later variations featured shorter cable runs to a whip aerial protruding from either the top of the rear canopy section (just to-port of centre) or the fuselage where the original wood aerial mast used to stand. Aircraft manufactured without the wooden mast, or those that may have had it removed during a maintenance down-time modification embodiment, may have either the canopy or fuselage-top whip installed. A late-war edition of the Ministry's ARI 5083 manual mentions "Rod Aerial type 87" and "Rod Aerial 257" which, when coupled with their respective Loading Units become "Aerial, aircraft, type 201" and "Aerial, aircraft, type 329" respectively.

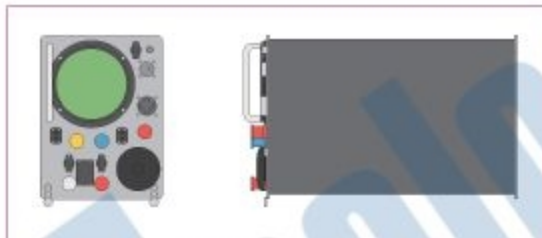
Type 62 indicating unit (typical - some manufactured with black front panel as well)

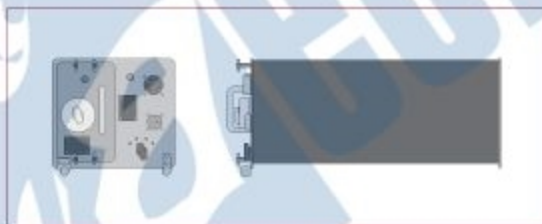
R-1355 Receiver (typical - some manufactured with black front panel as well)

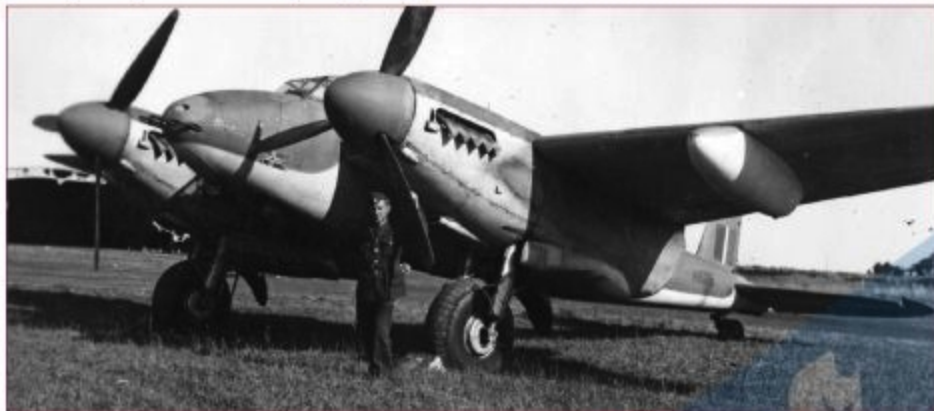
This unidentified 333 Sqn FB.VI illustrates the usual position of the flag marking, and an upper/lower paint demarcation that has all the appearances of a hand-brushed-in-the-field job. The light-coloured spinners, if white, may indicate that this is one of the ex 404 Sqn Mosquitoes taken on strength shortly after V-E Day.

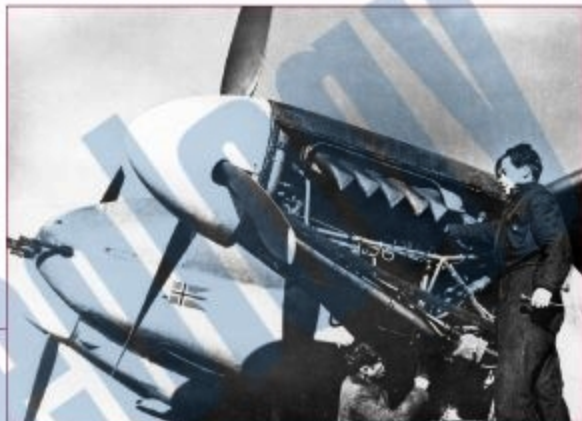
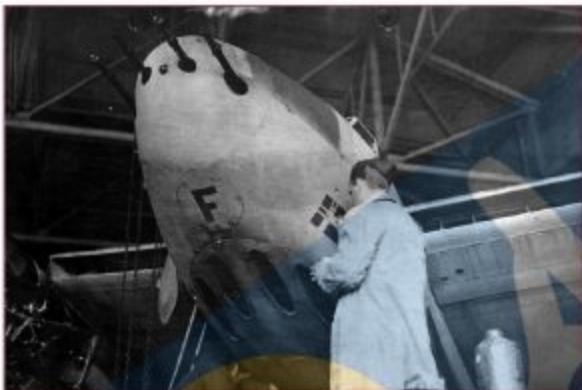
Mosquito FR116 at Banff in September of 1944. Note the clean tight-feathered appearance of the demarcation between the upper Extra Dark Sea Grey and lower Sky finishes, indicating that this may be a "to spec" finish vice the seemingly *ad hoc* field application of the new scheme. The position of the Norwegian flag and nose demarcation, as well as the ceno point on the upper drop tank, are also of interest.

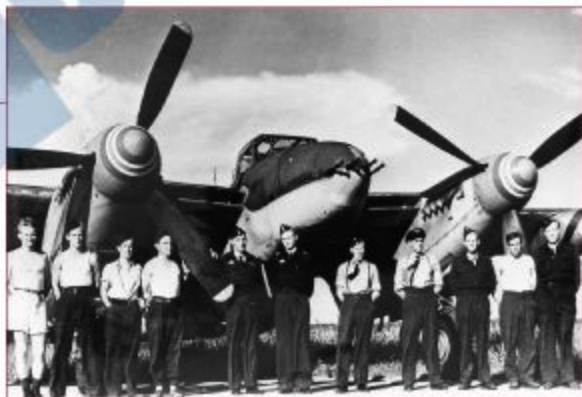
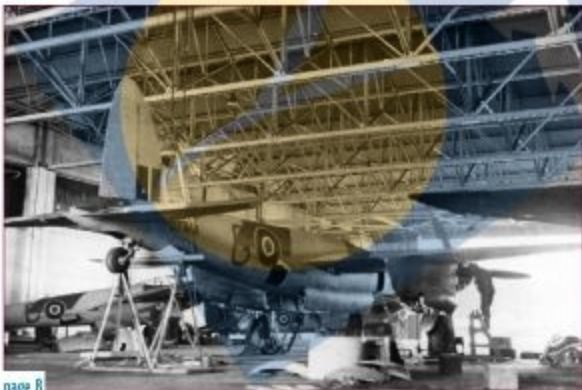
Two views of Mosquito E11 DZ744 levelled in trestle and sling with maintenance work underway. Note the 63 gallon long range fuel tank installed in the rear weapons bay (the bomb bay on later FB.VI aircraft).

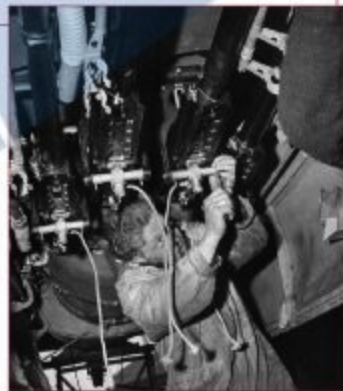
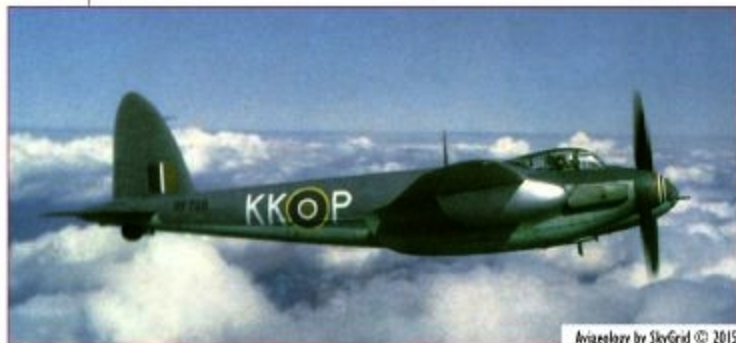
Another unidentified 333 Sqn FB.VI shows well the late-war / post-war spinner markings. This aircraft appears to have the bands applied over top of factory-finished Medium Sea Grey spinners. This is different than the Extra Dark Sea Grey on the spinners of our subject aircraft, RF769, in the photo below.
