Aviaology **Venturas in Canada 3**

8, 115 & 149 (BR) Squadrons, Western Air Command, RCAF

8 subjects to choose from

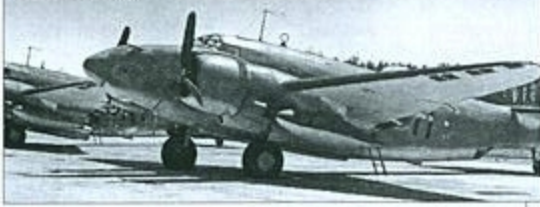
This detail, from a larger photo of a long line of 115 (BR) Squadron Ventura GR.V's at taken Tofino on 10 May 1944, shows some of the markings features of aircraft 2227 to good advantage. The US national insignia overpainting represented in the accompanying illustrations show up better in earlier photos of the aircraft, taken before the Canadian national insignia were applied. Note the small dipole aerial of the radio altimeter system installed on the next aircraft in the line-up. It is not known if this was installed on all (progressively) or only some WAC Venturas. It is therefore shown as installed in the illustrations.

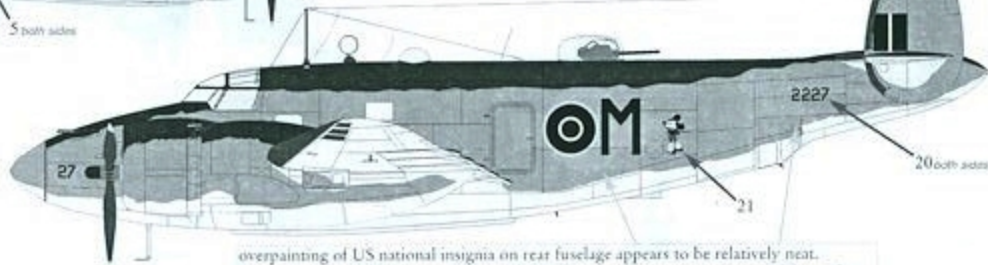
overpainting of US national insignia on rear fuselage appears to be relatively neat. Further to the rear, the temporary serial that was applied immediately after delivery has also been overpainted in the same colour - apparently a close match to intermediate blue.

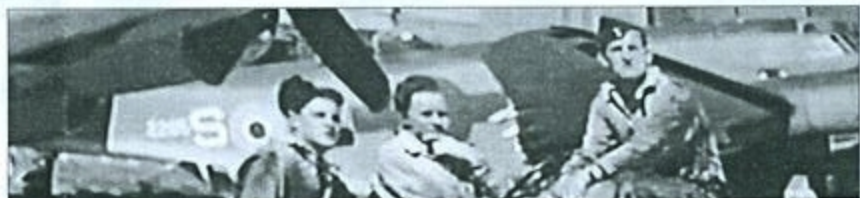
With the same ingenuity and dogged persistence he applies to achieving a steady output of stellar scale models, British writer, researcher, and modelmaker Tony O'Toole went beyond the usual "screen grab" and snapped this photo of the fleeting moment at which Ventura 2265 appears nearly full length on his large-screen TV while viewing *Son of Lassie*... capturing the aircraft's few moments in the spotlight during the shooting of this 1944 film. The nonstandard markings (white lettering not to spec, the rounded blue overly light) and scheme (for summer, 1944) suggest that the aircraft was made a spurious extra in the film by pulling her out of stored reserve and doing a quick ramp job of the markings. Note the overpainted US insignia on the fuselage in what appears to be US-spec Sea Blue. If this was a standard (of the day) operational machine, the finish and markings would have been very different (see pp. 4 & 5).

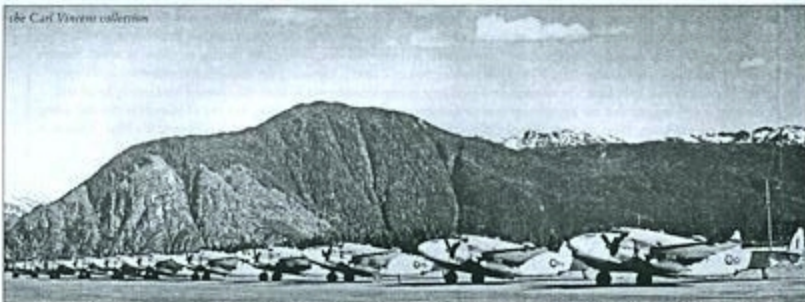
The 149 (BR) Squadron line-up at Terrace, British Columbia, in early 1944. The squadron disbanded in March 1944, and most, if not all, of its aircraft went to 8 (BR). All aircraft in the line-up appear to be in the saddleback ASW scheme. The disbandment date of 149, combined with the already well weathered appearance of the upper paintwork, indicates that this scheme may have been on the aircraft for some time already - most probably applied in the last months of 1943. The first three aircraft, Venturas P, H, and M were later photographed while in service with 8 (BR). The fourth aircraft is quite likely 2194 / B, the only early-nosed GR.V thus far confirmed as being in WAC service also ended up in 8 (BR) hands.

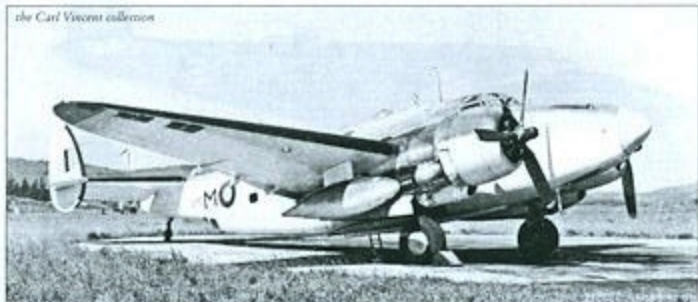
Ventura 2185 / M, at RCAF Station Patricia Bay, B.C. on 1 June 1944 - by now on strength with 8 (BR) Squadron. Interestingly, the 149 (BR) markings remain unchanged on this and a number of other examples. The weathered appearance of the upper paintwork is noteworthy and the gloss finish of the wing under surface is immediately apparent in this view. The dark tone under the wingtip seems to be an accent colour - possibly red - rather than a trick of the light. It shows up in a few other photos of saddleback scheme endowed Venturas. Note also the USN three-colour scheme remaining on the underswing drop tank. This aircraft had the distinction of flying the squadron's final war patrol on 16 May 1945.

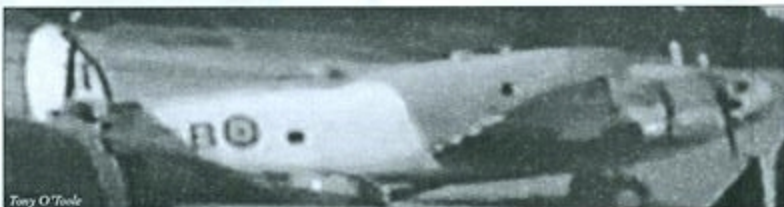
Another of Tony O'Toole's stills from the movie *Son of Lassie*, reveals Ventura 2194 filling a similar role to that played by the differently painted Ventura 2265 (see pg.3). Unlike 2265, this aircraft was actually operational with 8 (BR) when the film was being made. This supports the author's conjecture that any Venturas that may have gone to stored reserve prior to the new scheme coming into effect in WAC, were not refinished in the operational scheme until taken out of storage for the purpose of actual squadron assignment.

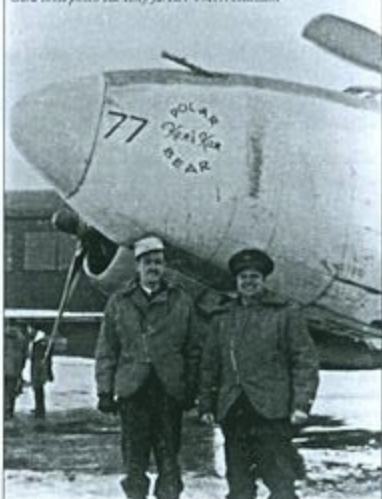
P/O Ken Reed (right) and an unidentified crewman pose with Ken's Kau at Prince George, British Columbia, presumably during a trip back to civilization during Operation Polar Bear. The .50 calibre gun FOD "socks", eponymous nose art, rough upper/lower camouflage paint demarcation, and substantial weathering of the White fuselage finish (note the distinctive web pattern made by airborne material thrown by the propeller) all show up well in this view. Striations created by the doped fabric strip reinforced nose cap can also be seen, and the joint between nose and fuselage appears to have a dark sealing material applied.

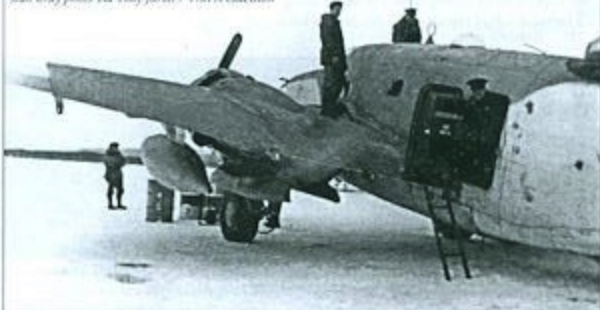
Ventura 2177 / H and crew, with refuelling in progress, on the frozen surface of Anahim Lake during Operation Polar Bear in February of 1945. Features of the saddleback scheme show up well in this image, as does the inboard edge of the Yellow Search Panel applied to the outer upper wing surfaces. The ailerons appear to have remained in the camouflage colours. The drop tank appears to be in the USN two-colour (Blue Gray and Light Gray, see Aviationology AODxx031) scheme, which would have been applied to this particular aircraft at the factory.

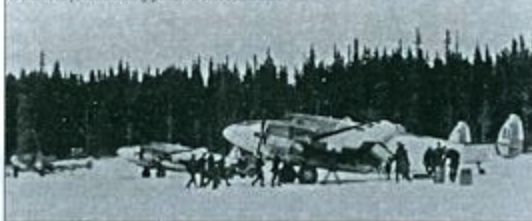
Operation Polar Bear Venturas 2189 (foreground) and 2177 and one other Lockheed twin (either a Lodestar transport or a Ventura) during a busy scene on Anahim Lake - a septicide diorama in 1:1 scale! The special Search Panel finish on the rudders of each Ventura are quite evident in this view. Ventura 2189 does not appear to be carrying underwing drop tanks in any of the extant Polar Bear photographs.

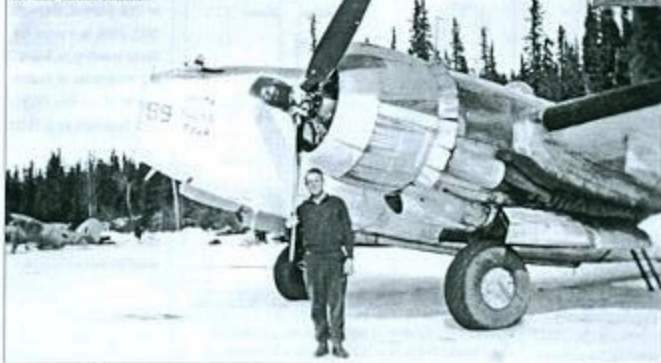
Ventura 2189 *Pat's Pile*, and company at Anahim Lake during operation Polar Bear. Oil stains on the lower part of the engine cowl and exhaust staining on the lower nacelle fairing above the main wheel well cover are not at all insubstantial. Note also the tire tread pattern, wheel hub details, weathered propeller hub, and the marker sense aerial installed on the lefthand bomb bay door. A ski-equipped Norseman is visible in the background.

Like 2177 (pg.6), Ventura 2189's forward fuselage flank has taken a bit of a beating from material thrown against the fuselage at high speed by the propeller. On the opposite side, the wet pattern was most likely different, with the blades on the up-swing when turning towards the fuselage. The "8" in the nose number is missing a part of a stroke, making it look like a nine. The pattern made by the overlaid fabric strips on the nose cap appear to be made more apparent by the frost-chilled surface.

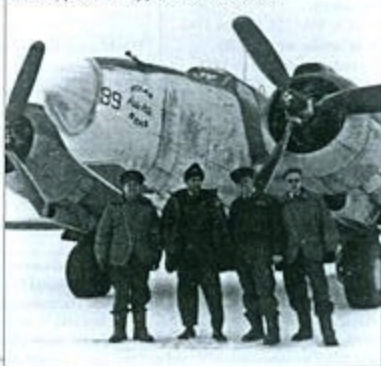
Ventura GR.V 2192, 8 (BR) Sqn

- PV-1 Ventura BuNo 33273 (c/n 5582) - became Ventura GR.V 2192 on entering RCAF inventory.
- TOS WAC 10 June 1943.
- In service with 8 (BR) Squadron, late March 1945.
