# RCAF Overseas Catalinas

## Catalina Mk.I, IB, & IVB of 413 & 422 Sqn

### The Saviour of Ceylon & Beyond

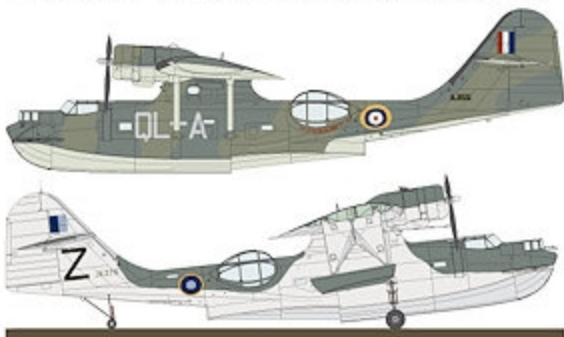
6 Wing access manhole covers feature fuel filler caps and related tank venting masts. One (per side) small inboard mast only for early Mk. Is in the Wxxxx and serial range and Mk.IIs in the AMxxx serial range. Later Mk.Is and Mk.IIAs have an additional identical pair of small masts outboard of caps.

float worm-drive lubrication holes (x5) and mechanism inspection hatch.

1 2 8x ordnance winching points centred on external reinforcement plates. Holes for winch cables were capped with neoprene bungs during flight.

1x Vickers .303 on pintle mount in turret (usually detached and stowed when not airborne on ops).

2x Vickers .303 on twin mount per blister.

20 Early ASV (Mk.I or short range Mk.II) for homing / navigation only. Aerials are in symmetrical pairs.

12 USN type flare chutes on all RAF-operated Catalina marques.

3 1x Vickers .303 on pintle mount in tunnel position on framework that swings up, to port when not in use. Note external armour plate on hull at gunner's prone position and on the tunnel hatch. Not on USN aircraft. Hatch swings upwards to the rear when opened.

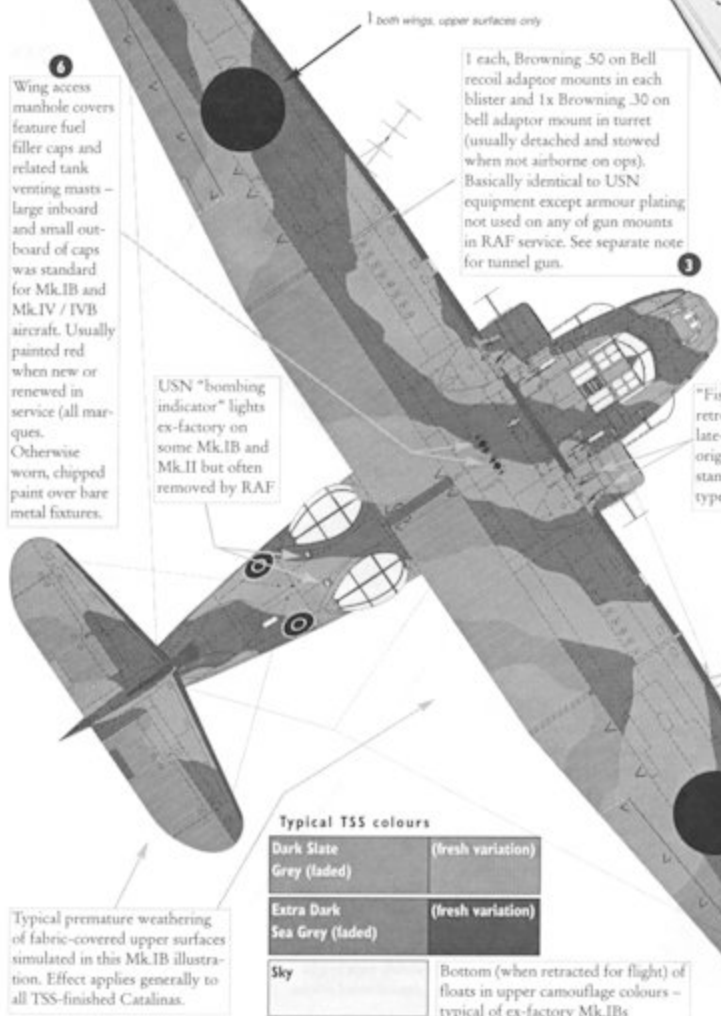
## Catalina Mk.IB in RAF Service Finish, Markings, & Version Notes

**6**  
Wing access manhole covers feature fuel filler caps and related tank venting masts – large inboard and small outboard of caps was standard for Mk.IB and Mk.IV / IVB aircraft. Usually painted red when new or renewed in service (all marques). Otherwise worn, chipped paint over bare metal fixtures.

**1**  
1 each, Browning .50 on Bell recoil adaptor mounts in each blister and 1x Browning .30 on bell adaptor mount in turret (usually detached and stowed when not airborne on ops). Basically identical to USN equipment except armour plating not used on any of gun mounts in RAF service. See separate note for tunnel gun.

**4**  
“Fishtail” exhausts retrofitted to many late-service aircraft originally fitted with standard Model 28-5 type exhausts.

Typical premature weathering of fabric-covered upper surfaces simulated in this Mk.IB illustration. Effect applies generally to all TSS-finished Catalinas.

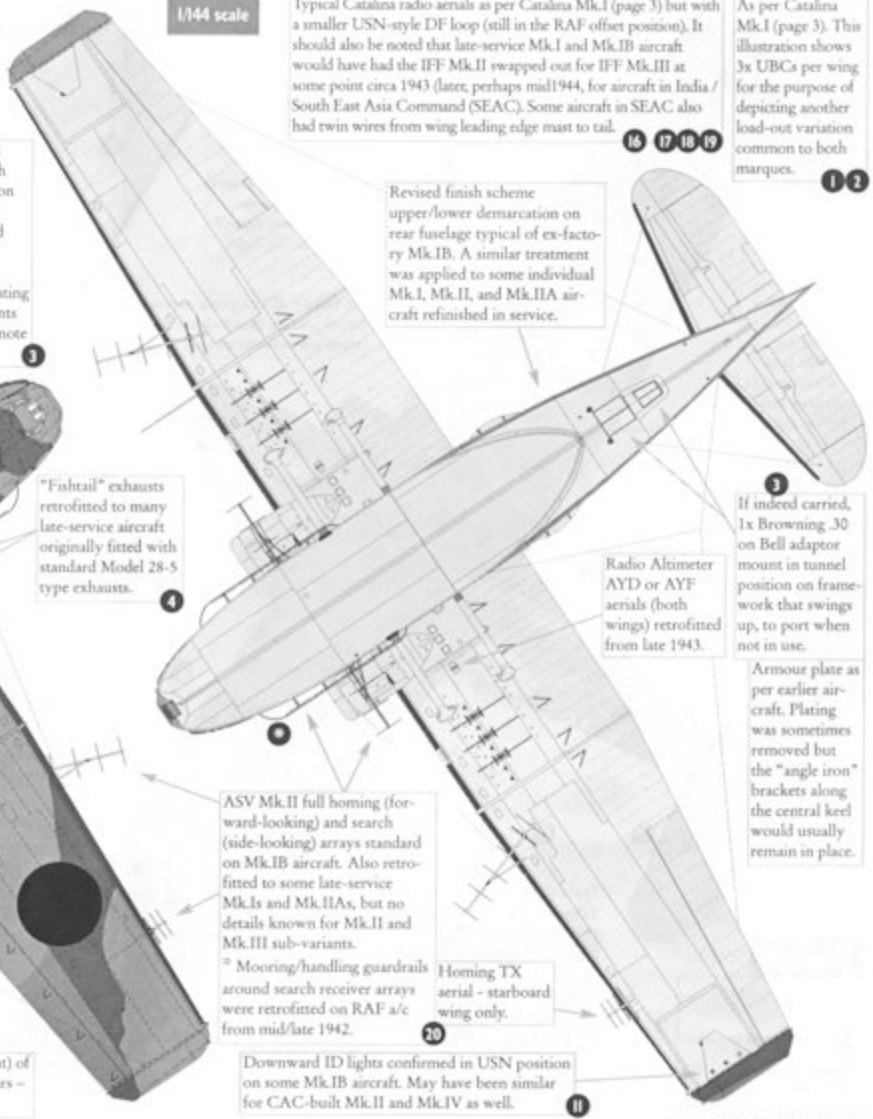
**Catalina Mk. IV / Mk.IVB in RAF (India/SEAC)  
Service – Finish, Markings, &  
Version Notes**

20  
ASV Mk.II homing-only Duplex (TX and RX on the same aerials) standard on many Mk.IV / IVB aircraft. ASG was installed on some late-production / late-service aircraft, with scanning dish in a pod mounted on top of the fuselage above the cockpit area.

3  
Gun armament per Mk.IB (see page 4). It is reasonable to assume that the CAC-built Mk.IVs would have had the same US guns as the CAC-built Mk.IBs, but it is not known if the smaller calibre guns on the CV-built Mk.IVBs were Browning .303s instead of American .30s. See separate note (below, right) for the tunnel gun station.

4  
Fuel dump pipes standard on Mk.IV / IVB aircraft, but sometimes installed only on one wing(?)

Radio Altimeter AYF aeriels (both wings) standard equipment on Mk.VI / IVB.

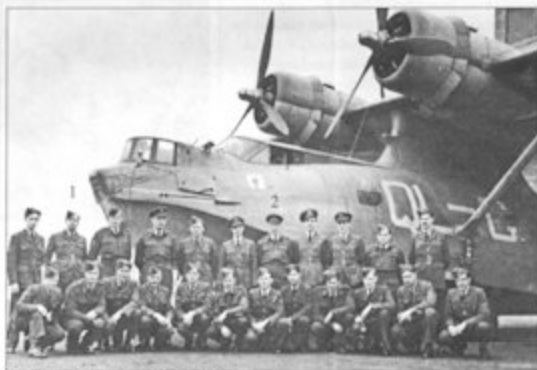
W8427 undergoing repairs in the UK on 17 March 1942, five days before departure for Ceylon. Of the Canadian squadron members present in the photo, navigator W/O G.C. "Bert" Chyette (1) and 1<sup>st</sup> pilot S/L L.J. "Len" Birchall (2) would depart as part of the crew of AJ155 on the 19<sup>th</sup>. The aircraft's chine walkway is being repaired in these photos, with parts of it laid on the nose ahead of the windscreen. Also of note are the early homing-only ASV aerials projecting from the nose (near the turret) and fastened between the wing leading edge and nacelle side. In the close-up, one can see the circular blanking plate (just above and forward of the emblem) where a different transmitter (TX) aerial had been located early on.

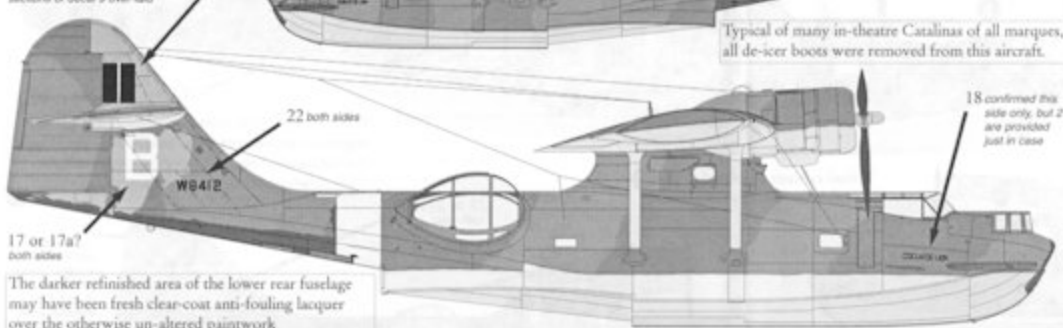
This profile is a graphic reconstruction of W8412 as it would most probably have appeared in an operational state early-mid August 1942 to late June 1943.

Typical of many in-theatre Catalinas of all marques, all de-icer boots were removed from this aircraft.

The darker refinished area of the lower rear fuselage may have been fresh clear-coat anti-fouling lacquer over the otherwise un-altered paintwork

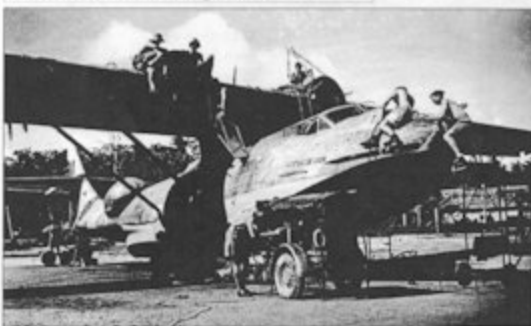
DND photos PL-1838, 1836, 6 1834

Decoras anyone? Tired warrior W8412 had just returned from an extended 26 January to 23 June 1943 to western detachment with F/L Buily and crew (8 aircrew plus skeleton groundcrew and a Royal Navy officer) before the plain air major overhaul illustrated in this series of photos was administered. Although subsequently test flown without incident on 27 August, the aircraft was test aside as unserviceable "awaiting disposal."

In the photo at left, the engines, floats, and control surfaces have been removed and refinishing of the hull and rear fuselage have begun. It seems likely that a change in rounded style and more white paint (thus modifying the TSS to approximate the new ASW standard spec) It is also possible that the UK-installed early bombing-only ASV set was to be replaced with a full ASVII set during this overhaul (note TX aerial mounting holes adjacent to nose turret well and RX aerial struts on wing leading edges), although not all early Mk.I's were upgraded.

In the upper right photo, one can just discern spot refinishing approximating the area of the lower fin occupied briefly by 'QL-B' codes in the summer of 1942. The UK-era 'QL-P' painted on the fuselage prior to that may have received a similar treatment the previous summer.

In the last photo a newly remounted engine (perhaps with a cowl from a different aircraft (note finish difference and also the cannibalised Catalina wing in the background) and fresh-looking DF loop aerial are visible. The twin main wire aerials (mast to tail) were present only on some Catalinas.

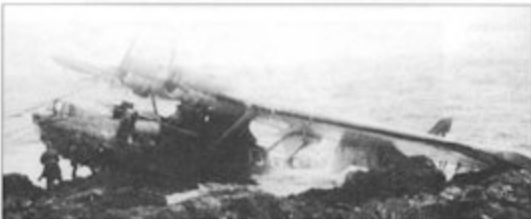
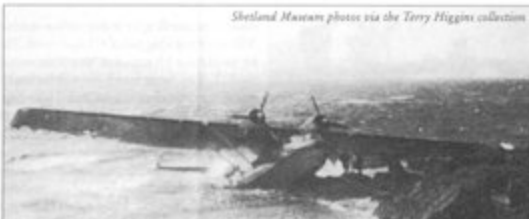
Shetland Museum photos via the Terry Higgins collection

Cast on the rocks: FP103 at Point of Grind, Whalsay, Shetland, after being forced down on the sea, floats-up, in violent weather 8 September 1942. The incident occurred on a long return flight from the Soviet Arctic when severe weather, violent enough to shred the aircraft's ailerons, was encountered not far from the intended destination, Sullom Voe. The crew all made it ashore and were sheltered at a nearby RAF radar station until a launch from Sullom Voe could come pick them up. The aircraft was fairly new when lost.

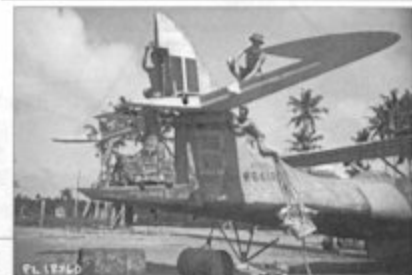
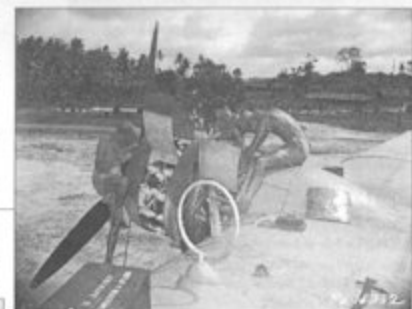
**Catalina Mk.IB FP103 | DG-A of 422 Sqn  
Murmansk, USSR (Det.) | August-September 1942**

- One of three - with FP105 (DG-B) and FP106 (DG-C) - early-production Mk.IBs equipped with full LR ASV.II radar suites.
- Guard rails around the fuselage-mounted search RX aerial arrays are clearly visible in the photographic prints (see item 20, page 4).
- Overload tanks may have been fitted for this detachment. (see profiles on page 10).

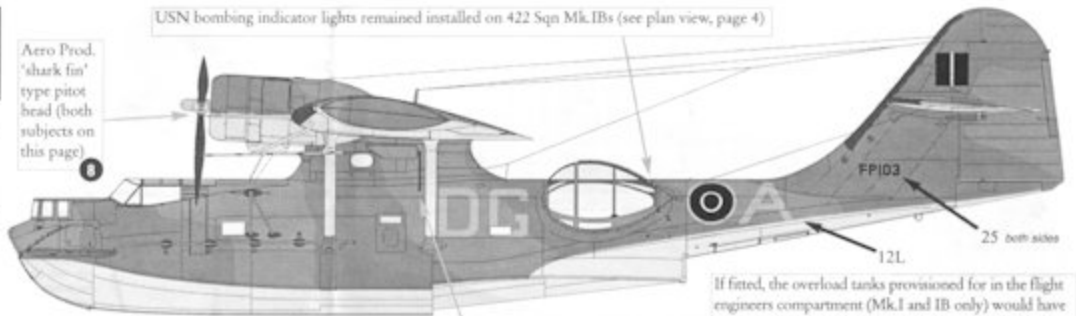
If fitted, the overload tanks provisioned for in the flight engineers compartment (Mk.I and IB only) would have the fuel transfer hose plus upper (superstructure) and lower (fuselage) elbow fittings present (this side only)

Fishtail exhausts retrofitted to this aircraft before delivery to squadron.

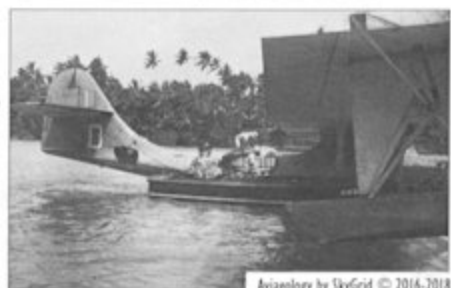
FP182 pictured at Koggala picketed in front of a 230 Sqn Sunderland and a Catalina Mk.IVB armed with six Mk.XI depth charges, circa April–June 1944. Despite the poor quality of the photograph, the general conditions of the fuselage can be discerned. It appears typical of Catalinas refinished from the ex-factory Temperate Sea Scheme with Sky under surfaces to the late-war ASW scheme (TSS tops with almost completely matt white side surfaces and gloss white under surfaces. One presumes that, if the factory finish on the hull did not receive the proper prep work prior to overpainting with white, then high-speed water erosion of the wetted area would be a possible result. The de-icer boots were usually removed on Catalinas that remained in SEAC for any length of time. The paired leading edges of the wings, tailplanes, and fins are fairly obvious. Those of the Mk.IVBs in the background appear similar.

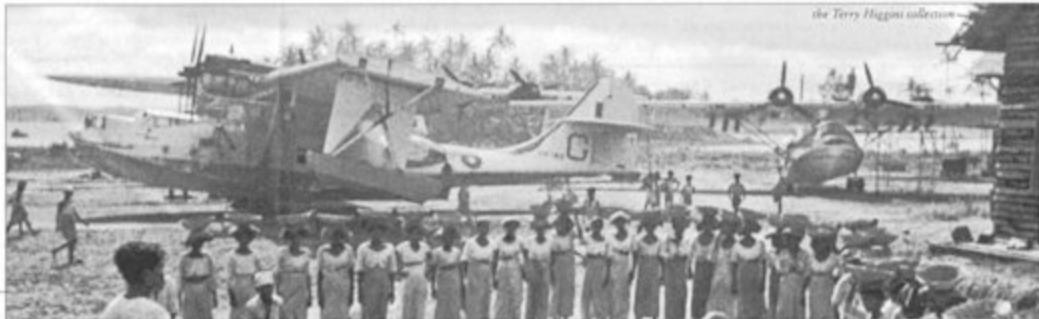
USN ABK (IFF Mk.III equiv.) aerial comms on Mk.IV / Mk.IVBs, but some a/c had RAF type 90 aerial under outer port wing instead.

Fishtail exhausts standard equipment on Mk.IVBs.

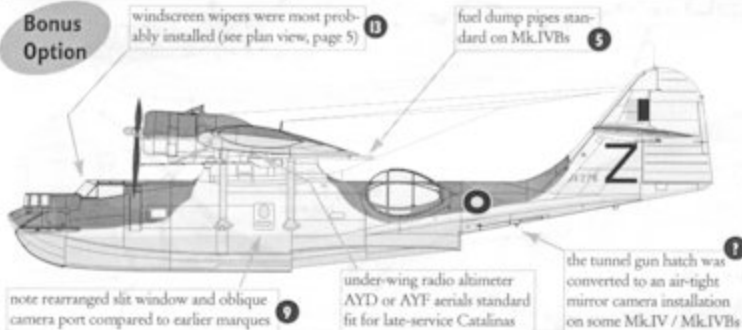
note rearranged slit window and oblique camera port compared to earlier marques

under-wing radio altimeter AYD or AYE aerials standard fit for late-service Catalinas

the tunnel gun hatch was converted to an air-tight mirror camera installation on some Mk.IV / Mk.IVBs

The slightly darker tone used to represent the white under-surfaces in this profile indicates the area typically treated with either a gloss white (No. 302A Glossy White) topcoat, or an anti-fouling gloss clear coat over the otherwise matt white camouflage paint finish. The demarcation illustrated here seems to have been the *de facto* standard while that illustrated in the starboard view on page 11 indicates the specification standard. All earlier TSS-finished Catalinas also received the clear coat treatment.

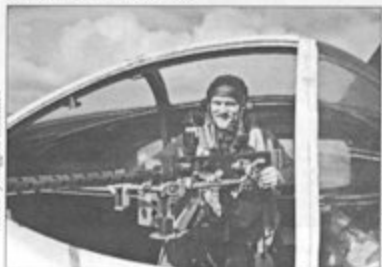
DND for the Terry Higgins collection

A nice detailed of the Browning .50 cal used in the waist "blister" positions on the Catalina Mk.IB, Mk. IV, and Mk.IVB. The complex Bell recoil adaptor mounting is the same as that used on USN aircraft but without the armour plating usually installed on the PBVs. The pintle plate on this particular aircraft has been adapted to mount a DR compass; this feature was not always present. This gun appears to have an ammo box tray attached, while USN guns were belt fed from huge boxes on the floor of the compartment.

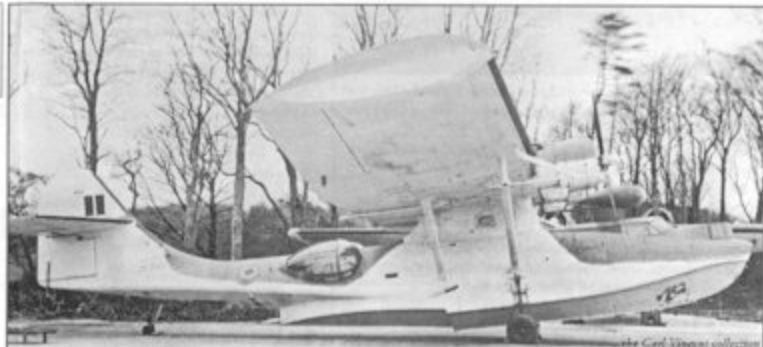
the Carl Lambert collection

BAC-built Catalina Mk.IVB JX286 at the Saunders-Roe Beumaris facility in March 1944 – the company was the primary contractor responsible for bringing Catalinas up to operational equipment standard at the time. The anti-submarine warfare (ASW) modified TSS finish (detailed elsewhere in this document) is typical of the BAC Mk.IVBs and CAC Mk.IVs of the period, but it should be noted that the Type C1 roundels applied at BAC were 34 inches in diameter (vice the RAF spec, 36 inches). While JX276 would have had this version of the scheme when it was ferried east, aircraft later refinished in service by the RAF may have had the higher upper/lower demarcation illustrated in the plan view page 7 and seen on JX431 (page 6). Other scheme variations – including overall Extra Dark Sea Grey uppers – came later.

The radar pod mounted above the cockpit housed the scanner and transmitter for ASG radar (frequently and erroneously referred to as ASD) which seems to have been installed on a special-order only basis, depending on whether or not the unit for which any given aircraft was destined was trained in its use. The duplex TX/RX aerials of the older ASVII remained for navigation and IFF interrogation purposes. 413 Sqn's first two Mk.IVBs (JX276 and JX281) arrived in April 1944 without ASG, but some of its subsequent arrivals may have had it, for the squadron's top radar mechanic went on a special ASG course in early June. After a time at the Coastal Command Development Unit, JX286 was ferried out to, 205 Sqn at Koggala in late 1944 where it served alongside a number of ex 413 Sqn Catalinas until June 1945.

Note that this aircraft also has late-model oil cooler fairings with two auxiliary bay cooling intakes scabbled on its flanks.

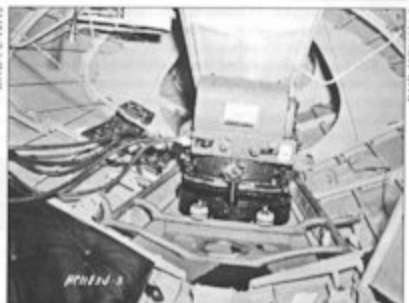
DND HC218143

This photo shows a swing-up tubular framed camera mount locked in the deployed position in an early Catalina Mk.I at RCAF Station Rockcliffe in September 1941. Note the brackets for the external armour plates affixed to the stowed hatch, and a Fairchild vertical camera installed in the rear bay of the mount. While the plate with circular mounting hole closer to the photographer would take the viewfinder, it could also mount the smaller Williamson F24 or its American equivalent, the Eastman Kodak K-24, with a simple 45° mirror housing mounted underneath for photographing attacked targets to the rear of the aircraft on ASW sorties.
