*AeroMaster.*

48-110

Marauding Emil's JG26

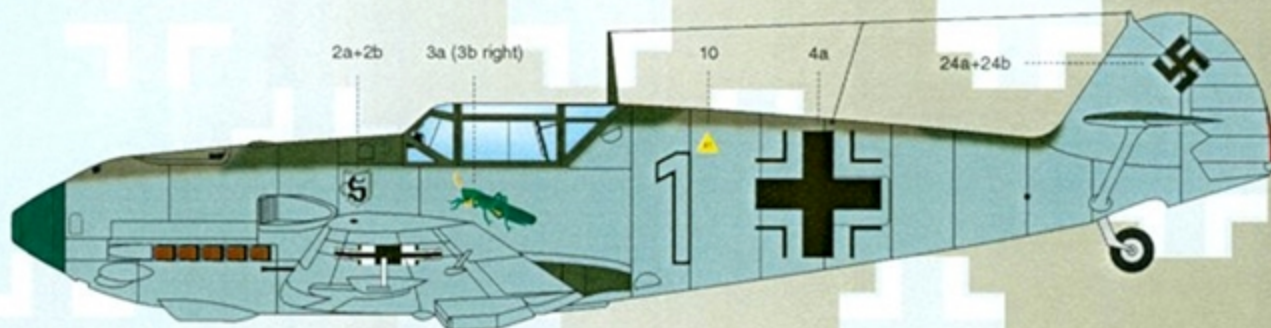
Bf-109E-1, 1./JG26 "Schlageter,"  
March, 1940. RLM 71 Dunkelgrün  
and RLM 02 Grau uppersurfaces.  
RLM 65 Hellblau beneath.

Note: photographic evidence seems to show that the unit badge, aircraft number "1" and fuselage cross of the A/C immediately below did not have the usual white background. Because there is some dispute about this, we have also supplied white backing decals for these items.

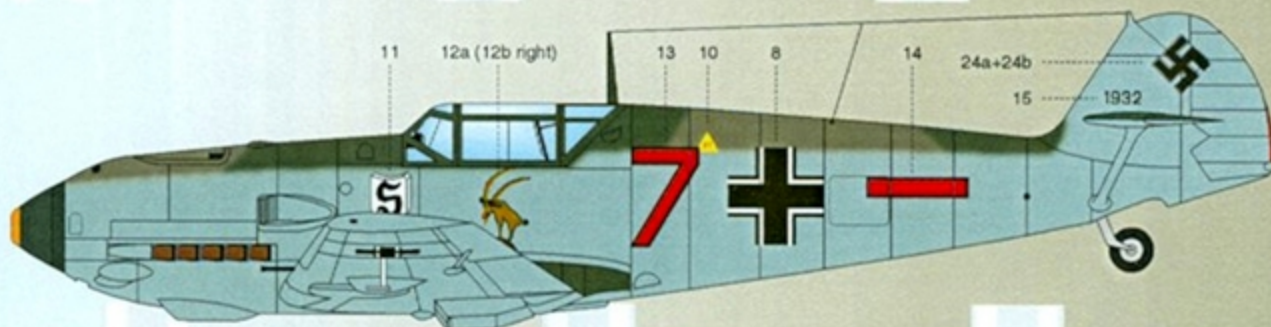
Bf-109E-3, W.Nr. 1932, 6./JG26  
"Schlageter," early 1940. RLM 71  
Dunkelgrün and RLM 02 Grau  
uppersurfaces. RLM 65 Hellblau  
beneath. RLM 04 or 27 yellow  
spinner tip.

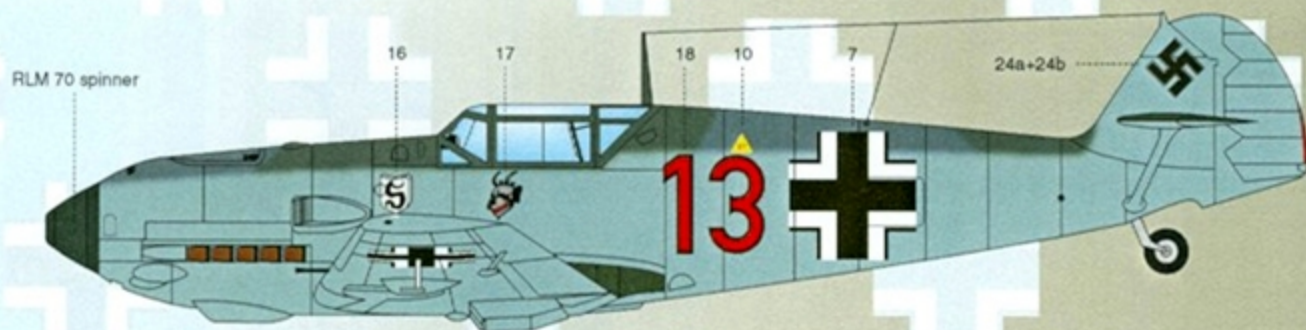
Bf-109E-1, 2./JG26 "Schlageter,"  
France, early 1940. RLM 74  
Graugrün and RLM 75 Grauviolet  
above. RLM 65 Hellblau or RLM  
76 Lichtblau beneath.

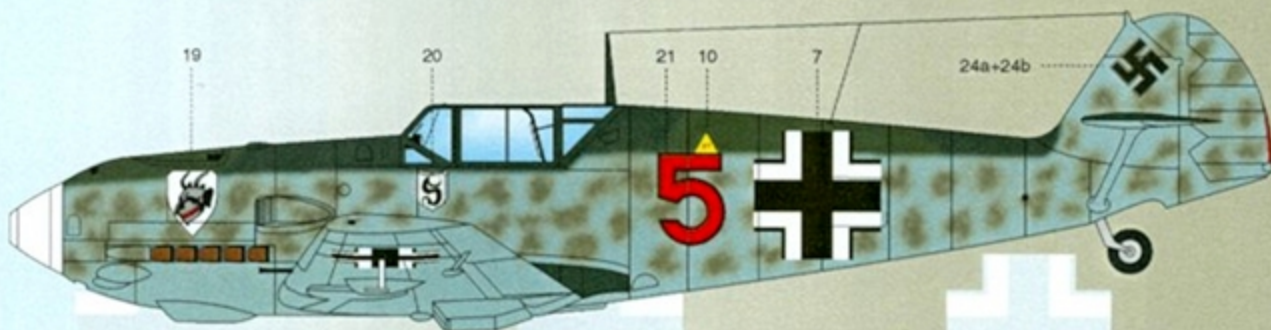
Bf-109E-4, 2./JG26 "Schlageter,"  
late 1940. RLM 70 Schwarzgrün  
and 71 Dunkelgrün uppersurfaces.  
RLM 65 Hellblau beneath. RLM 02  
fuselage mottling.

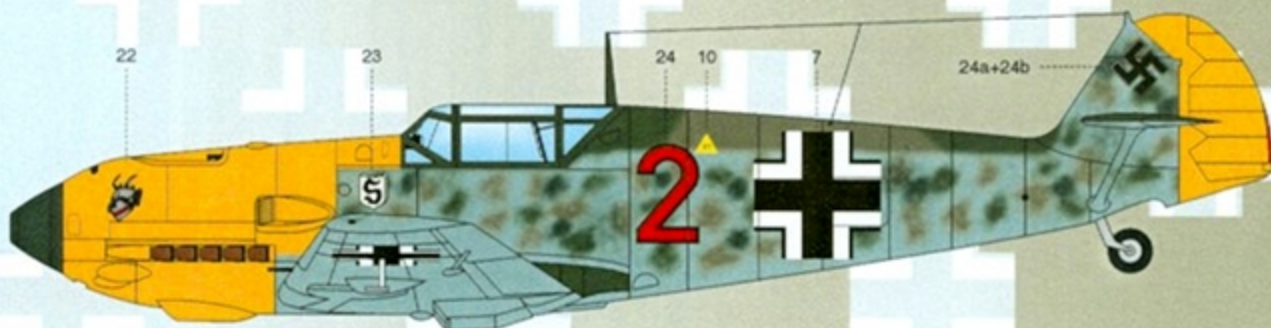
Bf-109E-3, 2./JG26 "Schlageter,"  
Nov. 1940. RLM 71 Dunkelgrün  
and RLM 02 Grau  
uppersurfaces. RLM 65 Hellblau  
beneath. RLM 71 and RLM 02  
fuselage mottling. Yellow nose  
and rudder.
