# AeroMaster

48-111 Butcher Birds Part 4

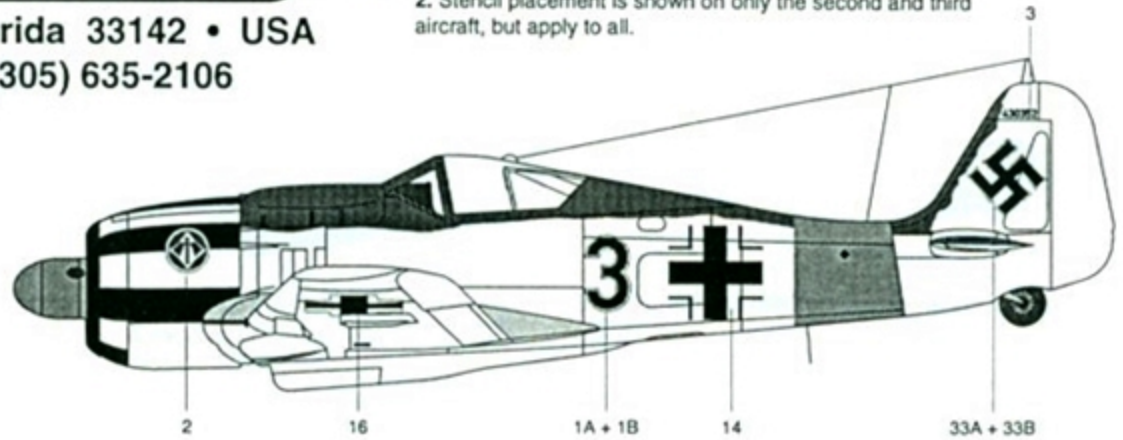
Fw190A-7, W. Nr. 430352, 2./JG1, Dortmund, Germany, early 1944. RLM 74/75/76 camouflage with red propeller spinner and rear fuselage band. Forward cowl ring is black with the remaining cowling alternating horizontal black and white stripes.

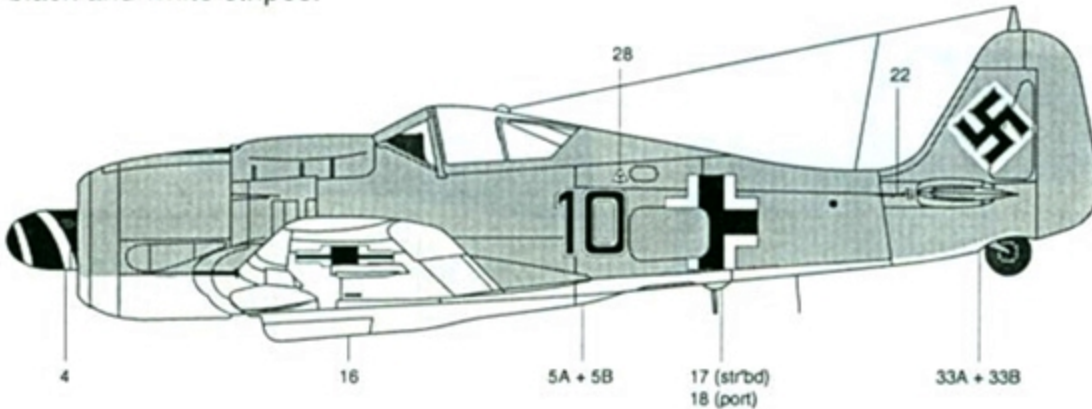
Fw190A-8, unit unknown, Kastrup, Denmark, 1945. Camouflage appears to be a spray of Light Green 83 over 76 undersurfaces. Propeller spinner black with white spiral. The radio compartment hatch is a replacement which lacks the Balkenkreuz.

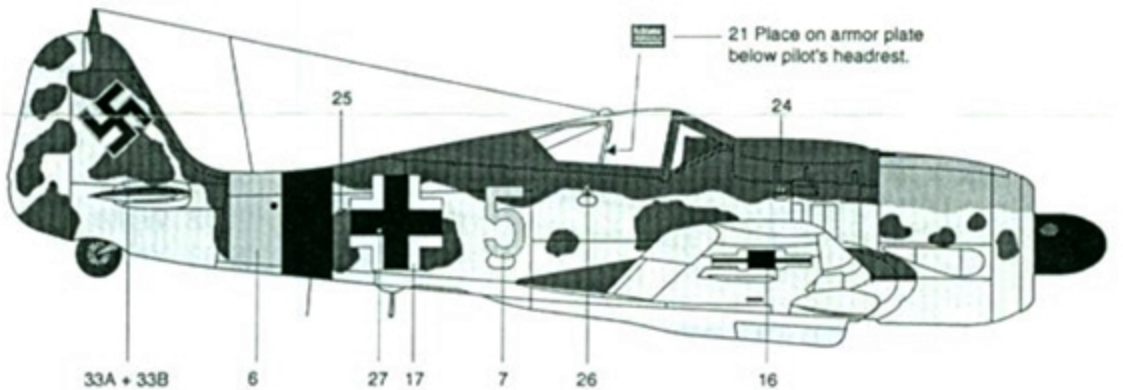
Fw190A-8, 3./JG5, France, summer 1944. RLM 74/75/76 camouflage. Black propeller spinner. Rear fuselage stripes are black and yellow. Heavy RLM 74 overspray almost obscures the underlying color. Note the 74 splotches on the cowling side.

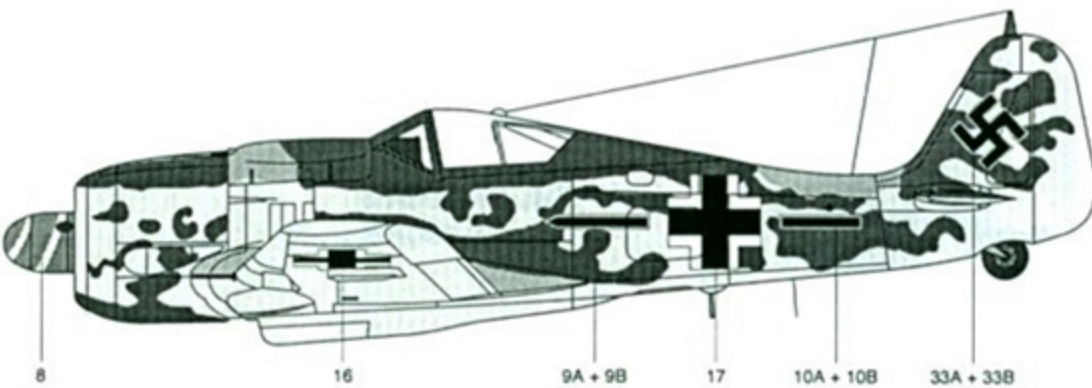
Fw190A-8, W. Gr. 21 Geschwader Stab./JG26, Germany, summer 1945. RLM 74/75/76 camouflage. Green (RLM 25?) propeller spinner with white spiral. Note the 74 shows heavy overspray along the fuselage sides from in front of the cockpit back to and including the vertical fin.

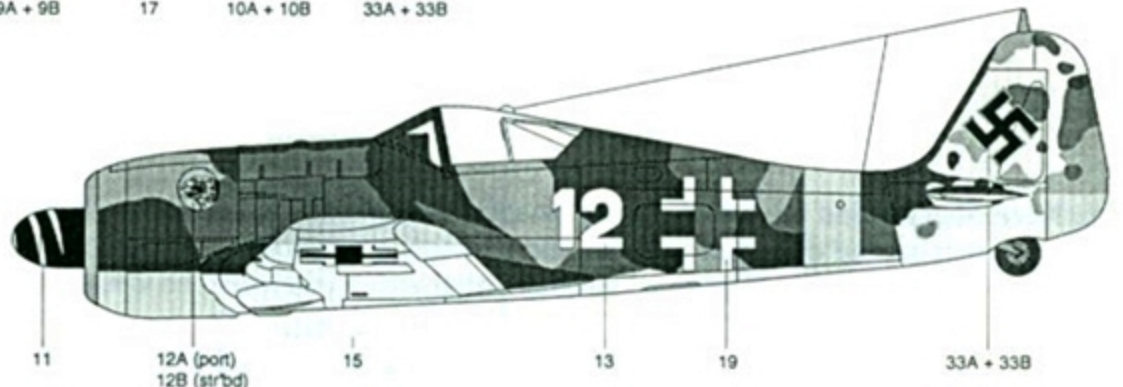
Fw190A-5, 1./JG51 "Molders", Russia, summer 1943. Camouflage appears to be field application of 70/71/83 over 76 undersurfaces. Lower cowling, bottom of rudder, lower wingtips and fuselage band are yellow. Black spinner with white spiral.
