AeroMaster.

48-232

RAMMJÄGER

Part 2

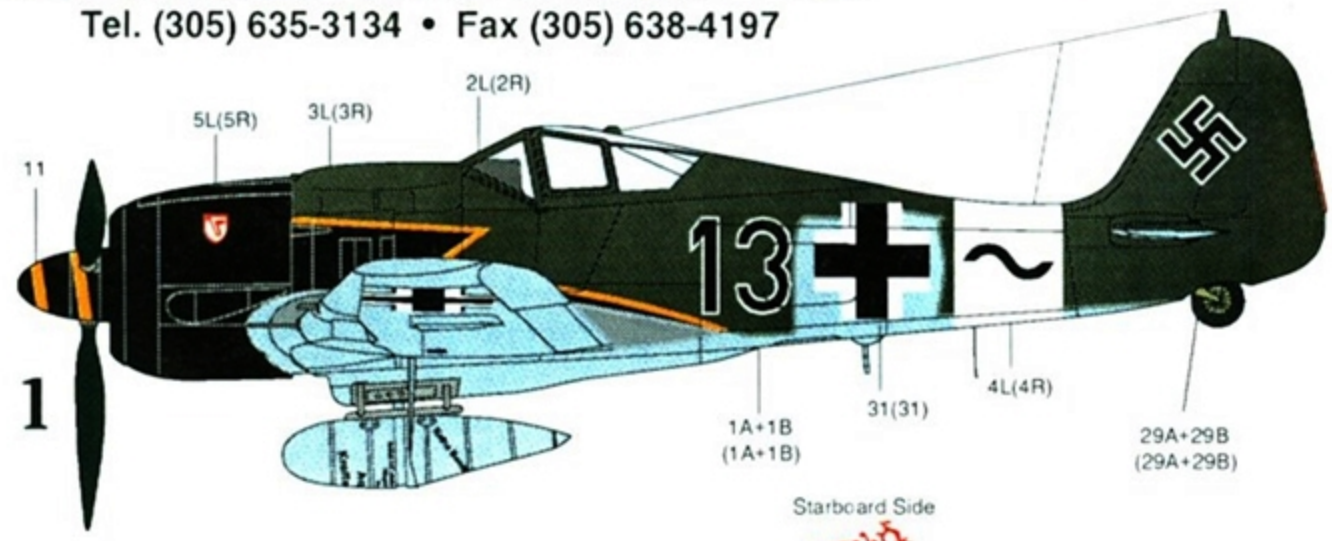
FW 190 A8/R8 of JG3. A/C appears to be camouflaged in RLM 74/75/76, although the whole fuselage is in RLM 74, with a light patch of RLM 76 behind the cross. Upper deck guns were removed to compensate for the extra weight of steel armor plating on the fuselage and the armored glass panels.

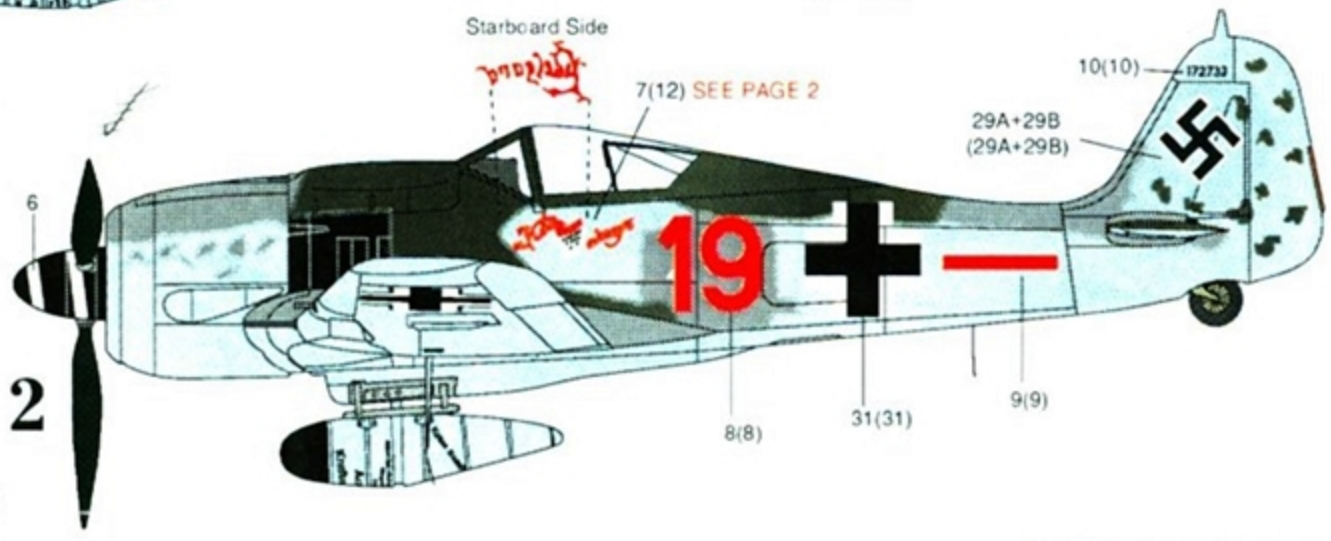
FW 190 A8 WK # 172732 of 5/II/JG300. Flown by Unteroffizier Ernst Schröder. "Kolle Olleg" was a German carnival slogan and badge. The right side name, Edelgard, was seen in at least 2 styles (both provided). A/C had no canopy pulleys (on top) nor antenna. Standard RLM 74/75/76 camouflage. Notice heavy patch of RLM 75 possibly covering earlier A/C number.

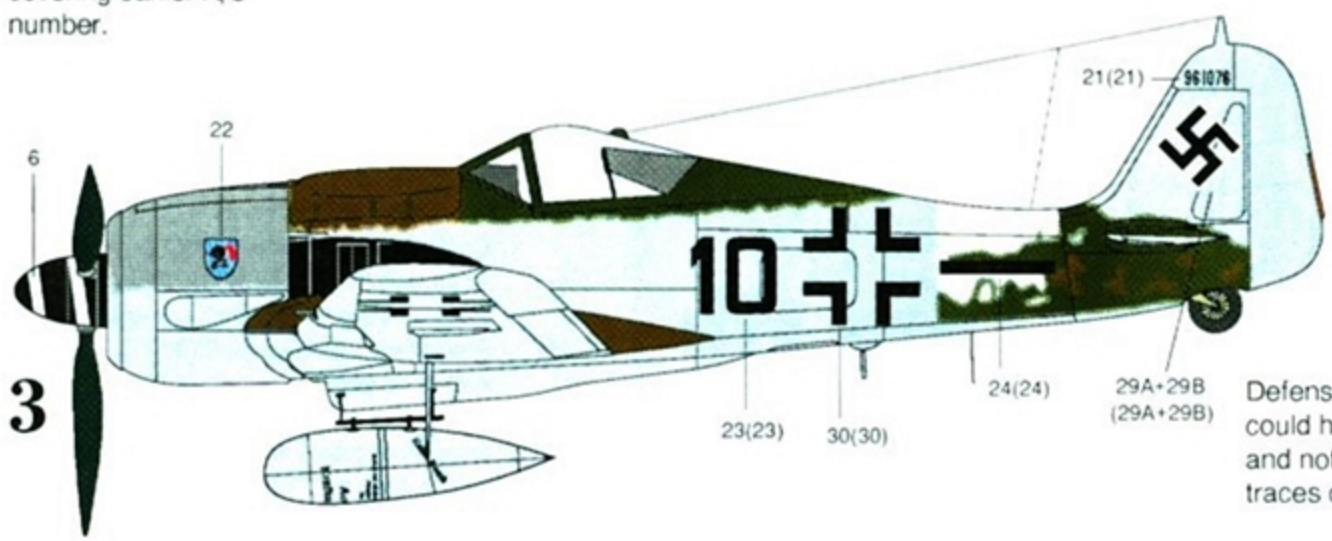
FW 190 A8 WR # 961076 of 5/JG4. Flown by Obergefreiter Axel Kessler 19 April 1945 to Bulltofta-Sweden while defecting. Probably not his personal A/C. A/C camouflage on 81/82/76 with no fuselage mottling except at the very rear end, possibly trying to cover a former Reich Defense Band. Exhaust panel could have been exhaust stains, and not a deliberate pattern. No traces of armor plating on photos.

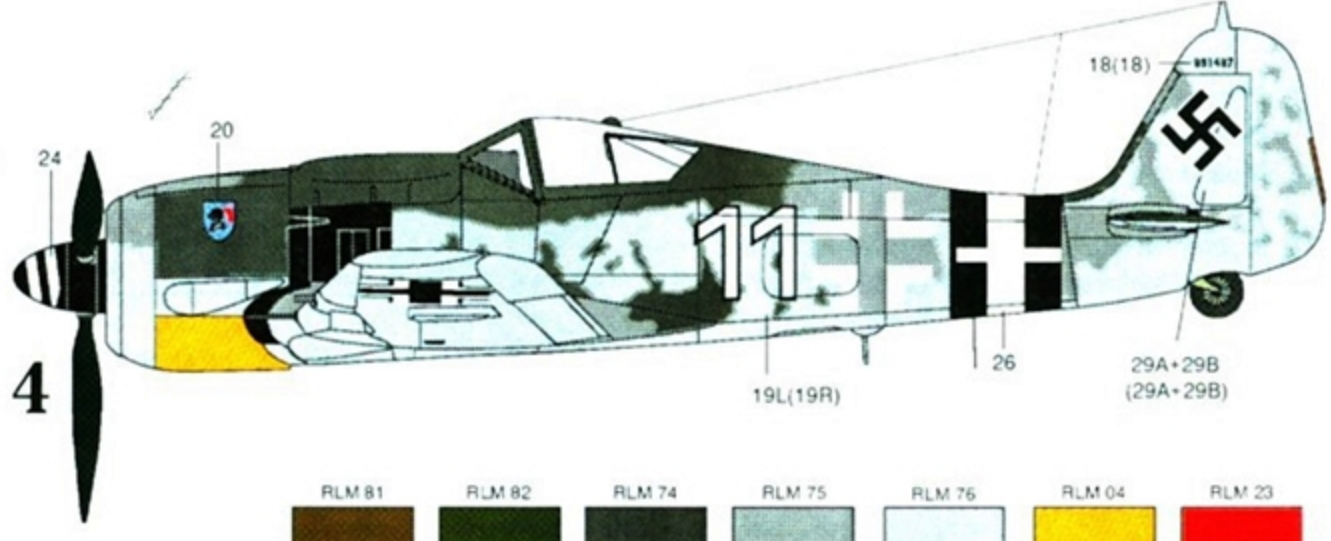
FW 190 A8/R8 WK # 641497 of 5/JG4. Flown by Gefr. Walter Wagner. A/C participated in Operation Bodenplatte, was damaged, landed, and then confiscated by the U.S. 404 FG USAAF. A/C was repaired and flown by U.S. personnel. Upper left cowling panel with badge seem to have been cannibalized off another A/C.
