*Convair F-106*

*Delta Darts*

**Part 1**

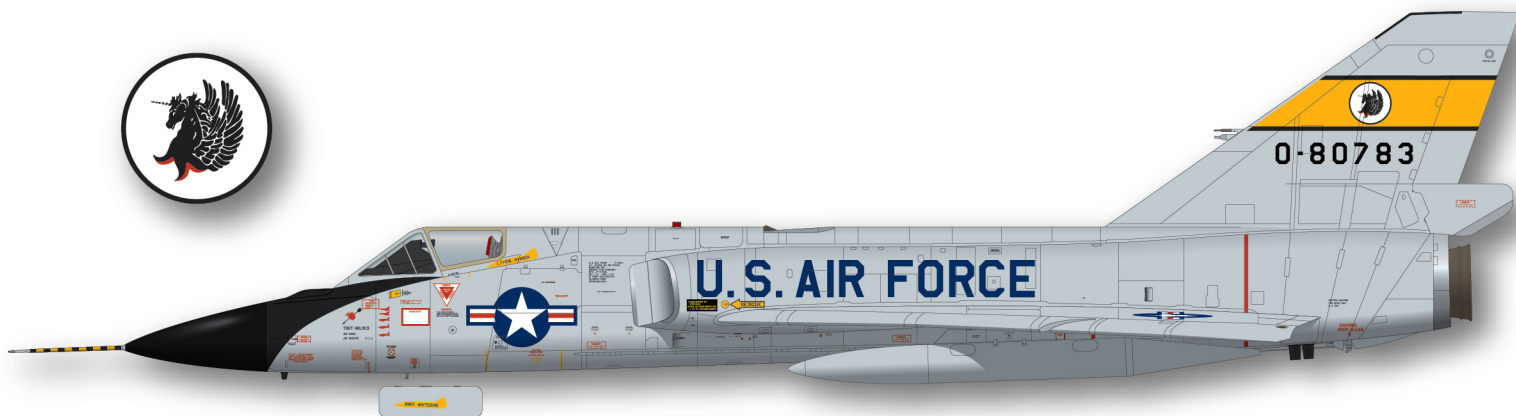
F-106A-100-CO, 58-0783, 2nd FIS, Wurtsmith AFB, Michigan, 1972. As seen at William Tell 1972 at Tyndall AFB.

- Early '70s airframe configuration
- IRST bulge
- Early canopy
- Late main wheels
- Air refueling receptacle
- Late stencils
- No UHF antenna
- TACAN antenna under nose
- Retractable anti-collision beacons, fixed open
- Tail hook
- Weber ejection seat
- SAGE antennas

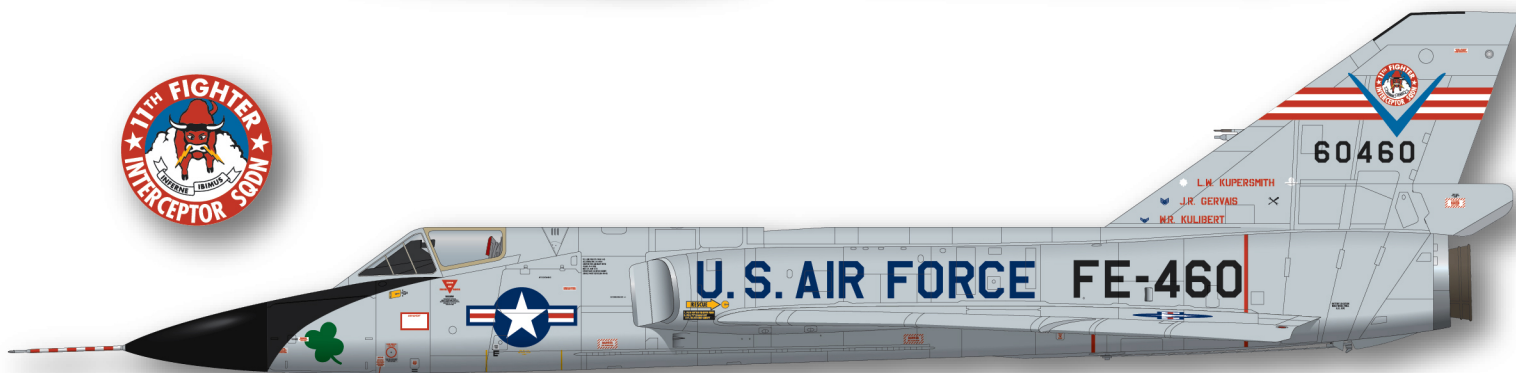
F-106A-1-CO, 57-0231, 11th FIS, Duluth International Airport, Minnesota, as seen at William Tell 1963, Tyndall AFB, Florida. Flown by squadron commander, Lt Col L.W. Kupersmith.

- Early 1960s airframe configuration
- No IRST bulge
- Early canopy
- Early main wheels
- No wing tanks (at William Tell)
- No air refueling receptacle (ARR)
- Early stencils
- No TACAN antenna under nose
- Retractable anti-collision beacons
- No UHF antenna
- Tail hook
- AIR-2 optical sight
- Convair ejection seat
- No SAGE antennas

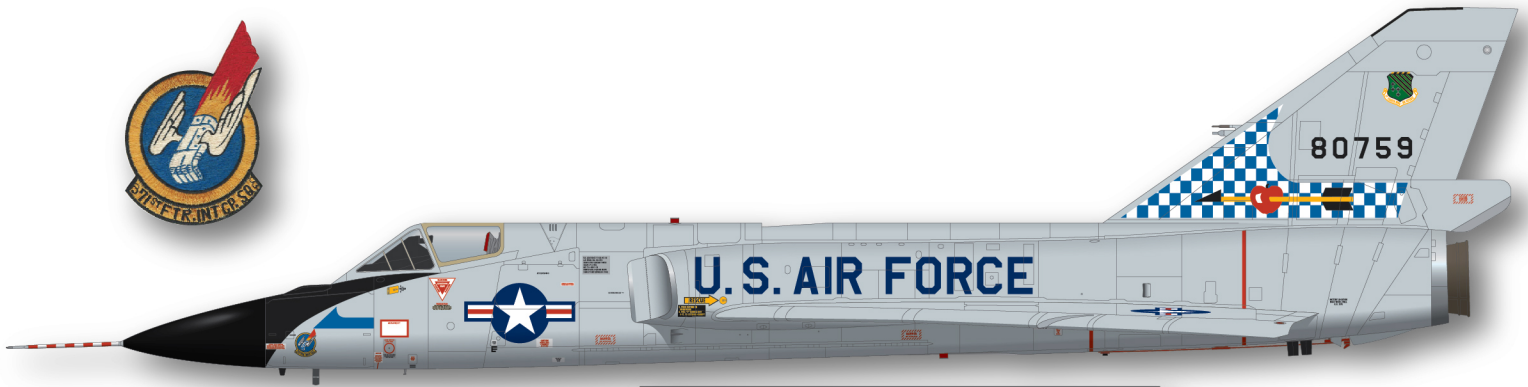
F-106A-95-CO, 58-0759, 71st FIS, 1st Fighter Wing (Air Defense), Selfridge AFB, Michigan, 1965. Participated in William Tell ADC World Wide Weapons Meet that year, flown to first place in the F-106 group by 71st commander, Lt. Col. Glendon Dunaway. This aircraft crashed on 11 April 1967 at Grand Island, Nebraska.

- Mid-1960s airframe configuration
- IRST bulge
- Early canopy
- Late main wheels
- No wing tanks during WT
- No air refueling receptacle (ARR)
- Mix of early and late stencil styles
- Early style UHF antenna under nose
- TACAN antenna under nose
- Retractable anti-collision beacons, fixed open
- Tail hook
- AIR-2 optical sight
- Convair ejection seat
- SAGE antennas

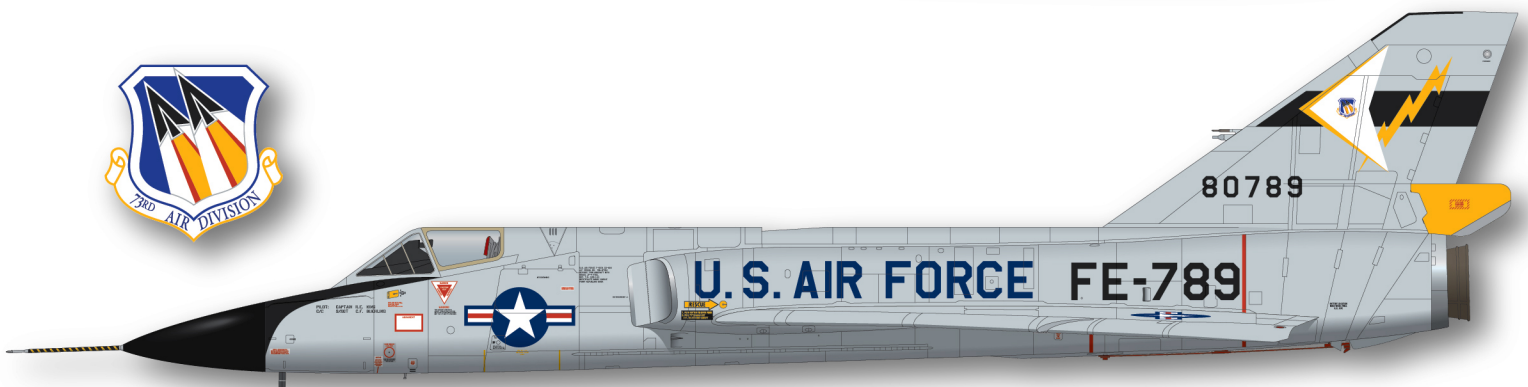
F-106A-100-CO, 58-0789, 73rd Air Division, Tyndall AFB, Florida, 1964.

- Early 1960s airframe configuration
- No IRST bulge
- Retractable anti-collision beacons
- Early main wheels
- No wing tanks
- No air refueling receptacle (ARR)
- Early stencils
- 'Point guards' around hook shoe
- UHF antenna under nose in non-standard forward position
- Early canopy
- Tail hook
- AIR-2 optical sight
- Convair ejection seat
- No SAGE antennas

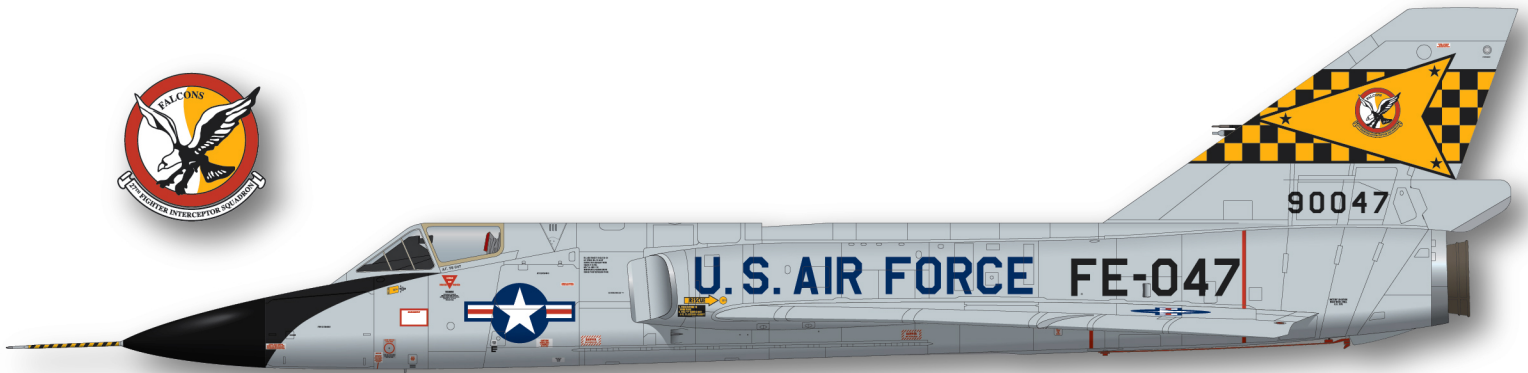
F-106A-110-CO, 59-0047, 27th FIS, Loring AFB, Maine, 1961.

- Early 1960s airframe configuration
- No IRST bulge
- Early canopy
- Tail hook (no snubber)
- AIR-2 optical sight
- Convair ejection seat
- No SAGE antennas
- No 'point guards' around hook shoe
- No TACAN antenna under nose
- Retractable anti-collision beacons
- Early main wheels
- No wing tanks
- No air refueling receptacle (ARR)
- Early stencils
- No UHF blade antenna
- No black rain erosion strip on top of vertical fin

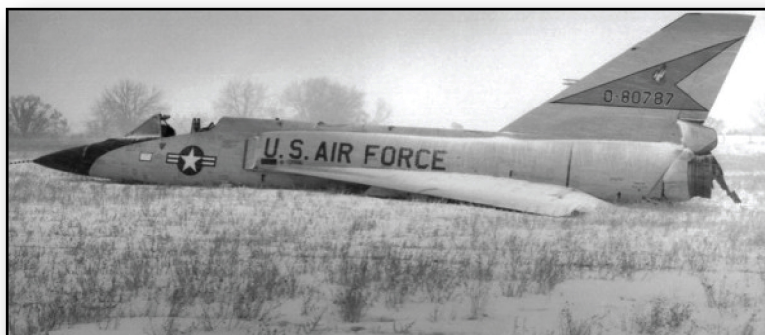
F-106A 58-0787 gained her notoriety when, on 2 February 1970, her pilot, Capt. Gary Faust of the 71st FIS inadvertently entered a flat spin while engaged in air combat maneuvering. He attempted to break the spin by deploying the drag chute, but was unsuccessful. Following established procedure, he bailed out of the spinning Six. To his amazement, between the force of the seat leaving the aircraft and the change in CG caused by his departure, the aircraft recovered itself and went on its merry way! He had trimmed the aircraft for takeoff, and reduced the throttle to idle prior to bailing out, and thus configured, the aircraft entered a shallow descent, touching down on open pasture land near Big Sandy, Montana. The throttle was still at idle, and the snow on the ground allowed the aircraft to continue "taxiing" under its own power for some distance. It finally ran out of fuel almost two hours later. Local farmers rescued Capt. Faust uninjured from the local mountains on their snowmobiles.

A recovery crew from the F-106 depot at McClellan AFB, California was sent to salvage '787. One of the maintenance officers was quoted as saying that if the aircraft had had any less damage, he would have flown it out of the pasture! The wings were removed and the aircraft loaded on a flatbed rail car and taken to McClellan. She was repaired and returned to service with the 49th FIS at Griffiss AFB, New York where she served out the rest of her days as an active interceptor. In 1986 she was given a VIP retirement and remains on display at the National Museum of the United States Air Force in Dayton, Ohio.

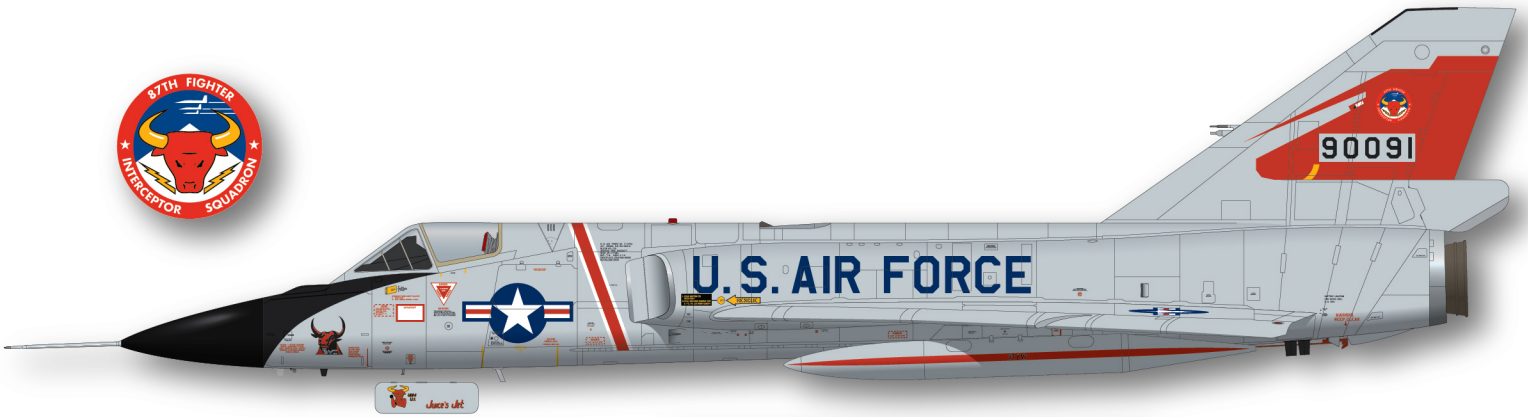
F-106A-125-CO, 59-0091, 87th FIS, K.I. Sawyer AFB, Michigan, 1978

- Late airframe configuration
- IRST bulge
- Late canopy
- Tail hook
- Weber ejection seat
- SAGE antennas
- Yaw sensor vane
- TACAN antenna, aft location
- Fixed anti-collision beacons
- Late main wheels
- Air refueling receptacle
- Late stencils
- Late style UHF antenna

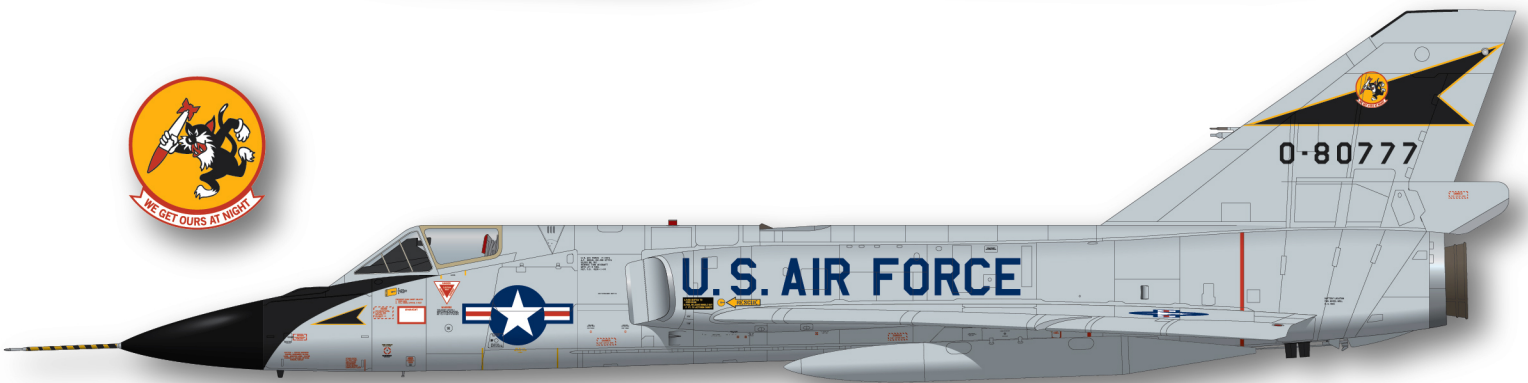
F-106A-100-CO, 58-0777, 319th FIS, Malmstrom AFB, Montana, 1972

- Early '70s airframe configuration
- IRST bulge
- Early canopy
- Late main wheels
- Air refueling receptacle
- Late stencils
- No UHF antenna
- TACAN antenna under nose
- Retractable anti-collision beacons, fixed open
- Tail hook
- Weber ejection seat
- SAGE antennas

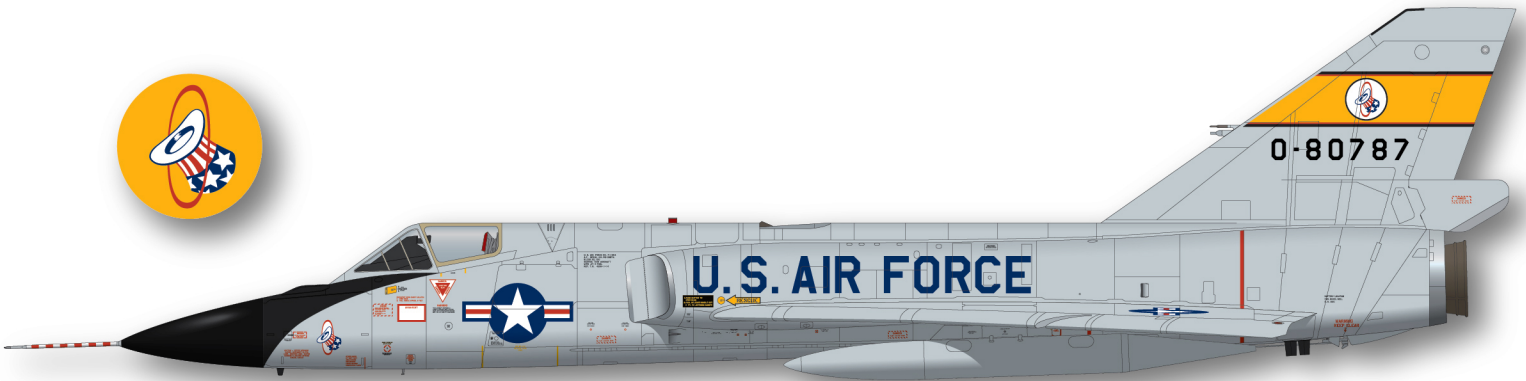
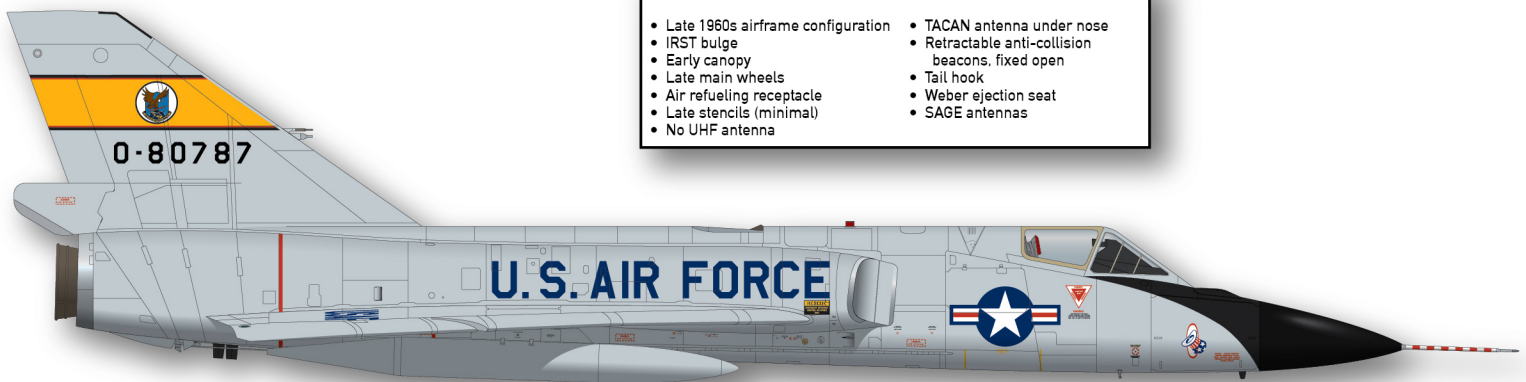
F-106A-100-CO, 58-0787, 94th FIS, Selfridge AFB, Michigan, May 1969.

- Late 1960s airframe configuration
- IRST bulge
- Early canopy
- Late main wheels
- Air refueling receptacle
- Late stencils (minimal)
- No UHF antenna
- TACAN antenna under nose
- Retractable anti-collision beacons, fixed open
- Tail hook
- Weber ejection seat
- SAGE antennas

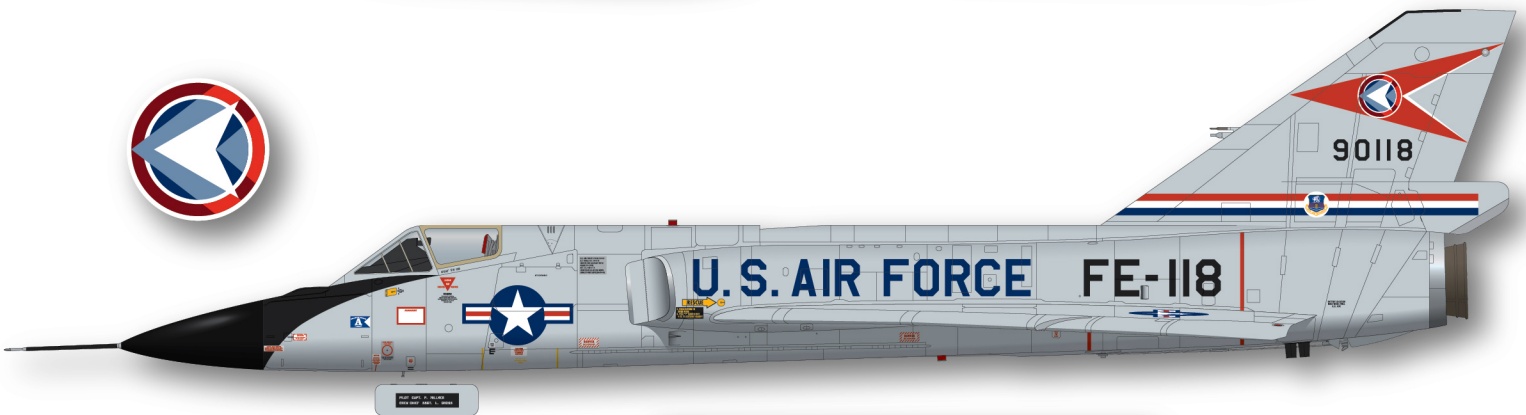
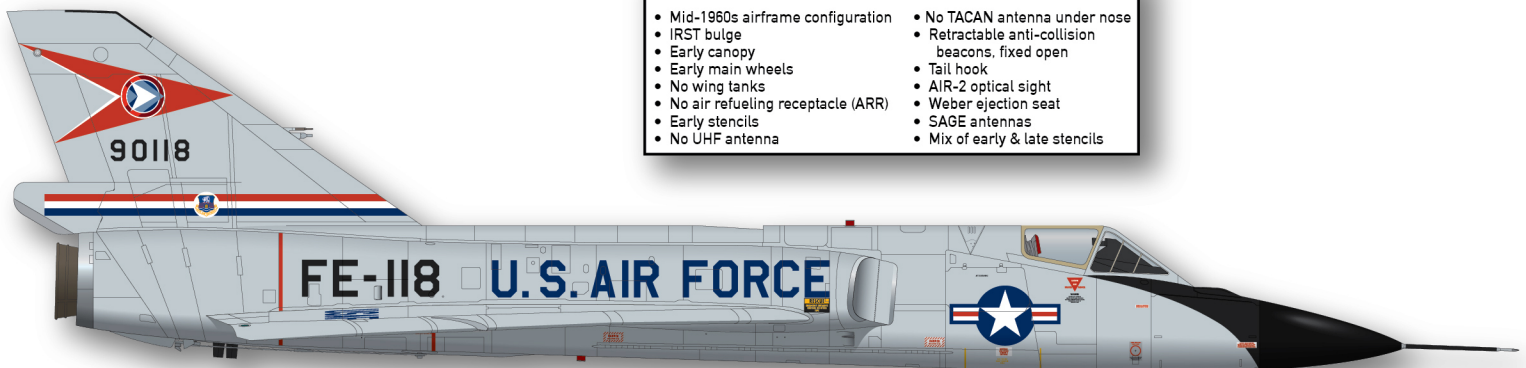
F-106A-130-CO, 59-0118, 329th FIS, George AFB, California, 1964.

- Mid-1960s airframe configuration
- IRST bulge
- Early canopy
- Early main wheels
- No wing tanks
- No air refueling receptacle (ARR)
- Early stencils
- No UHF antenna
- No TACAN antenna under nose
- Retractable anti-collision beacons, fixed open
- Tail hook
- AIR-2 optical sight
- Weber ejection seat
- SAGE antennas
- Mix of early & late stencils
